Novelli, V., Ngoma, I., Kloukinas, P., Kafodya, I., De Risi, R., Macdonald, J., & Goda, K. (2019). *Seismic Vulnerability Assessment of Non-engineered Masonry Buildings in Malawi*. Paper presented at 7th International Conference on Computational Methods in Structural Dynamics and Earthquake Engineering , Crete, Greece.

SEISMIC VULNERABILITY ASSESSMENT OF NON-ENGINEERED MASONRY BUILDINGS IN MALAWI

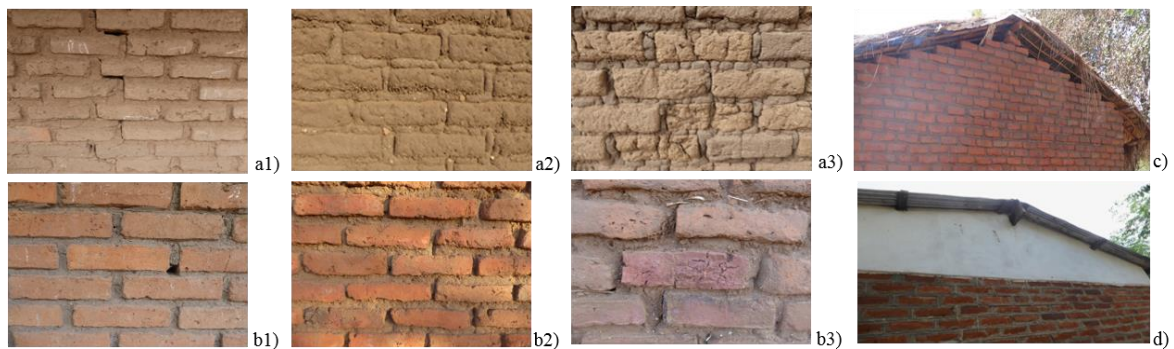
Figure 2: a1) and b1) good; a2) and b2) medium and a3) and b3) poor fabric quality of unfired and fired bricks, respectively c) thatched roof and d) metallic sheet roof

Most of the observed buildings (82%) were made of fired bricks, since these are affordable materials to be sourced on-site, and they do not require high construction skills. Mud mortar was identified for 76% of the inspected buildings, while cement mortar, observed for the remaining inspected houses, is gradually being adopted. Fabric quality varies considerably from poor to good and underlines the need of assessing the building performance by defining me-

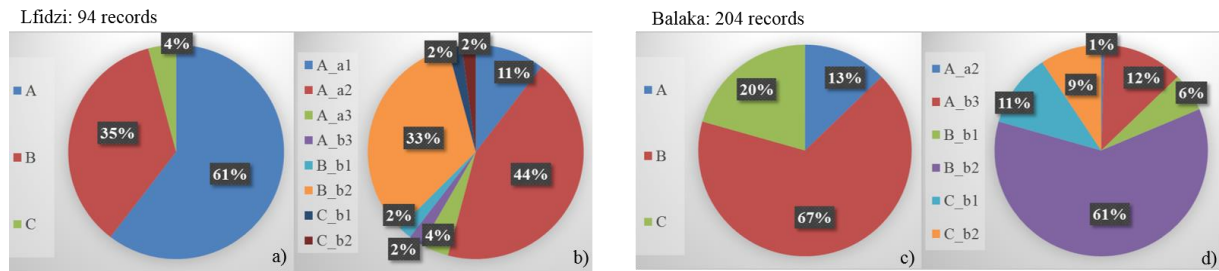
Figure 4: a) and c) Building typology distribution (A, B and C) identified in Lifidzi and Balaka; b) and d) each identified building typology is associated to inspected material type and fabric quality, where a1 and b1 is good; a2 and b2 is medium and a3 and b3 poor fabric quality for unfired and fired bricks.

Before discussing the results obtained for the two different sites, Figure 4(a) and 4(c) are presented to illustrate the building distributions identified for building typologies A, B and C for Lifidzi and Balaka, respectively. As expected, the weakest typologies A, built with unfired bricks and low low-quality of fired bricks, has a higher concentration in Lifidzi, where houses are constructed in rural communities by local builders/artisans in absence of technical guidance. Building typologies B and C are more concentrated in Balaka, where houses are built using materials with better mechanical properties than the ones in rural areas. Figure 4(b) and 4(d) present the fabric quality observed in the three typologies, underlining, as expected, that materials adopted in Balaka have better fabric quality than the ones observed in Lifidzi. This can be underlined by typology A, where 79% of the houses belonging to this class for Lifidzi are made of unfired bricks of medium/poor fabric quality against the 4% in Balaka, where houses are mainly made of fired bricks of poor fabric quality. For typology B, 16% of the houses in Balaka are made with bricks of high fabric quality compared to 6% identified in Lifidzi, while the remaining houses for both sites are made of bricks with medium fabric quality. For typology C, houses belonging to this class, cover only 4% of the inspected houses in

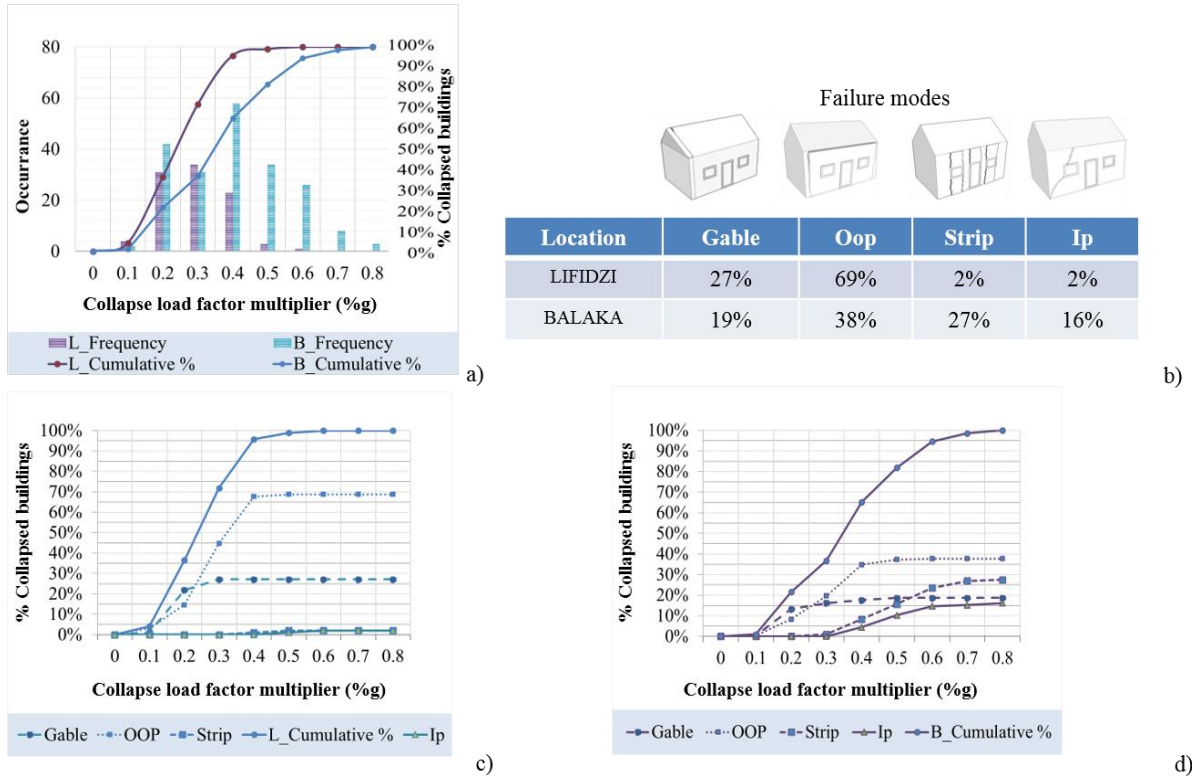
The occurrence of λ , evaluated for the selected building stocks in Lifidzi and Balaka are illustrated in Figure 5(a). The median of λ , being 0.24g and 0.38g for Lifidzi and Balaka respectively, underlines that the buildings inspected in Lifidzi are weaker than the ones inspected in Balaka, as they fail for lower values of λ . This is also highlighted by the slope of the cumulative curve: the one derived for Lifidzi has a higher slope than the one derived for Balaka (i.e. for $\lambda = 0.35g$, 72% and 35% of the inspected buildings fail in Lifidzi and Balaka, respectively).

Figure 5: a) Collapse load factor multiplier distribution in the selected building stocks in Lifidzi (L) and Balaka (B); b) failure modes distribution; c) collapse load factor multiplier distribution for the failure modes identified in Lifidzi (L) and d) collapse load factor multiplier distribution for failure modes identified in Balaka (B)

The failure modes associated with the identified collapse load factor multipliers are illustrated in Figure 5(b). These are classified into four categories: 1) *Gable*: predominantly occurs on walls with gables which are not connected to roofs, and therefore fail in overturning; 2) *Oop*: Out of plane, predominantly occurs on single-skin walls with a low-quality material and poor connection with orthogonal walls and roof, causing overturning of a single façade; 3) *Strip*: predominantly occurs on single-/double-skin walls with a medium-quality material and a good connection with orthogonal walls and roof; causing overturning of a strip of piers and spandrels; and 4) *Ip*: In-plane, predominantly occurs on single/double-skin walls with a medium-quality material and a good-quality connection with orthogonal walls and roof; causing shear failure of a single façade.

As expected from the on-site surveys, since a lack of connections between the walls and roof and low-quality construction materials were frequently observed in the inspected buildings in Lifidzi, *Oop* is the most likely failure mode with a percentage of 69%. By contrast in Balaka, there is a smaller percentage of buildings failing in *Oop* (38%), and a higher percentage of buildings failing for *Strip* (27%), where the latest occurs on buildings with stronger

Figure 5(c) and 5(d) show the distribution of collapse load factor multipliers for the failure modes identified in Lifidzi and Balaka, respectively. *Gable* failure modes occur for the lowest values of λ (smaller than 0.3g) for inspected buildings with tall gables, resulting in separation of their roofs. Buildings in classes B and C, classified in a medium high-quality class, mostly fail for *Strip* and *Ip* failure modes with the highest values λ , (greater than 0.3g). Regarding *Oop*, λ varies from a minimum value of 0.1, values identified for buildings belonging to typology A, to 0.4, values identified for buildings belonging to typologies B and C.

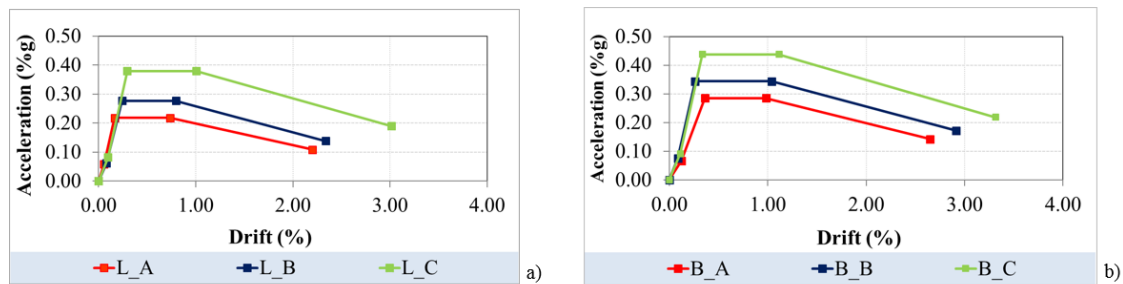
Figure 6: Median capacity curves for a) the building typologies: A, B and C for Lifidzi and Balaka, respectively

Figure 6 shows the different capacity curves derived for the building typologies A, B, and C identified in Lifidzi and Balaka, respectively. As expected from the definition of the three typologies, it is noticeable that the building typology A (class of buildings characterized by low-quality materials and construction details) has the lowest values of acceleration and drift compared to B and C. Clearly, the derived capacity curves are capable of capturing the different performances for the single typology. Furthermore, they underline that classifying buildings according to structural conditions and differentiating mechanical properties with respect to the fabric quality improve the reliability of the vulnerability obtained for the single typology. This can be observed from the different values of acceleration obtained for the sin-

gle typologies (i.e. typology A: maximum acceleration is 0.21g, and 0.29g for Lifidzi and Balaka, respectively), which point out that buildings of the same typology (same construction materials and roof types) located at different sites and subjected to different levels of quality control are likely to behave differently under seismic events.
