Novelli, V., Ngoma, I., Kloukinas, P., Kafodya, I., De Risi, R., Macdonald, J., & Goda, K. (2019). *Seismic Vulnerability Assessment of Non-engineered Masonry Buildings in Malawi*. Paper presented at 7th International Conference on Computational Methods in Structural Dynamics and Earthquake Engineering , Crete, Greece.

## SEISMIC VULNERABILITY ASSESSMENT OF NON-ENGINEERED MASONRY BUILDINGS IN MALAWI

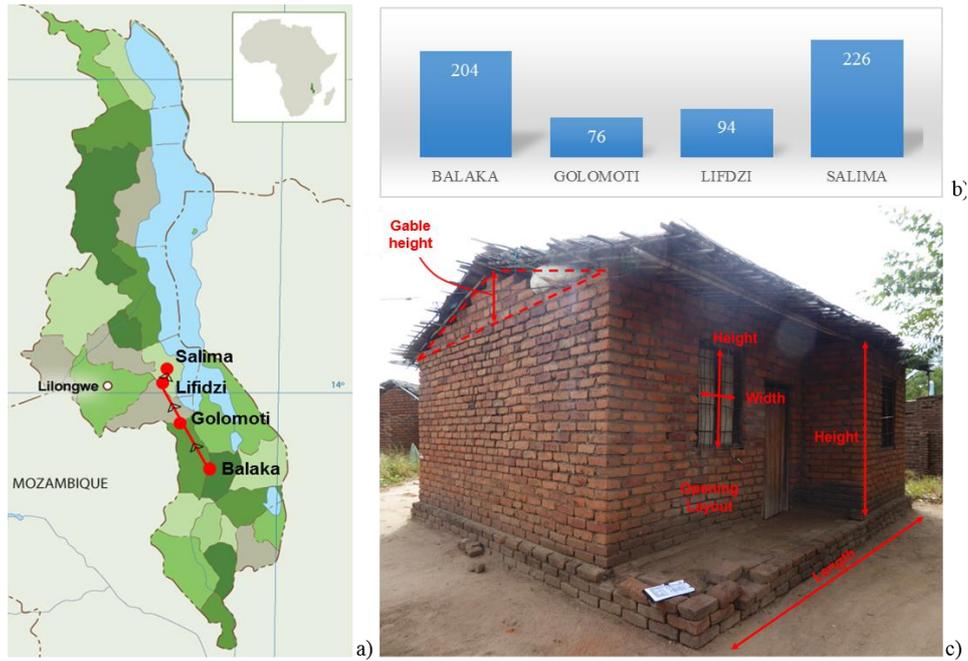
Figure 1: a) Building survey locations, Balaka, Golomoti, Lifidzi, and Salima; b) number of façades collected for each site c) geometrical measurements collected for each inspected façade

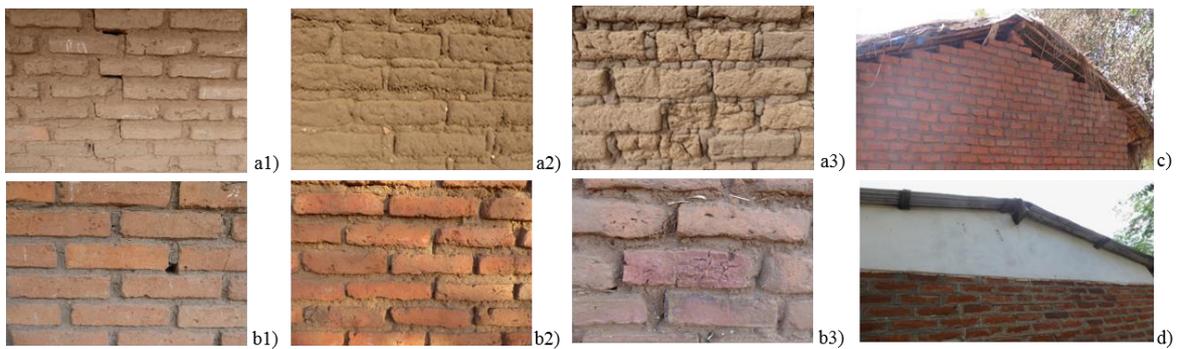
Figure 2: a1) and b1) good; a2) and b2) medium and a3) and b3) poor fabric quality of unfired and fired bricks, respectively c) thrached roof and d) metallic sheet roof

Most of the observed buildings (82%) were made of fired bricks, since these are affordable materials to be sourced on-site, and they do not require high construction skills. Mud mortar was identified for 76% of the inspected buildings, while cement mortar, observed for the remaining inspected houses, is gradually being adopted. Fabric quality varies considerably from poor to good and underlines the need of assessing the building performance by defining me-

The most common typology observed in Malawi, B, representing 52 % of the buildings, is rated as medium seismic vulnerability (see Figure 3(b)). These buildings were made of fired bricks characterized from poor to a good quality fabric (Figure 2(b1), (b2), and (b3)). Due to the presence of mud mortar in these houses, the bonding between bricks is considered poor, therefore connections between walls were assumed weak. The construction details varied significantly, as well as maintenance levels.

Typology C covers 28% of the inspected houses (see Figure 3(c)). These were made of fired bricks from poor to good quality fabric (Figure 2(b1), (b2), and (b3)) and cement mortar. Generally, these houses had a larger floor plan than the typical plan. Due to the extended plan size, irregularities were likely to occur (e.g. portico and re-entrant corner). Most of these houses had corrugated metallic sheets supported by timber elements or truss, and good structural detailing (e.g. adjacent walls and walls/roof are connected). The good structural quality of these houses can be also attributed to the presence of strengthening elements (e.g. ring beams).

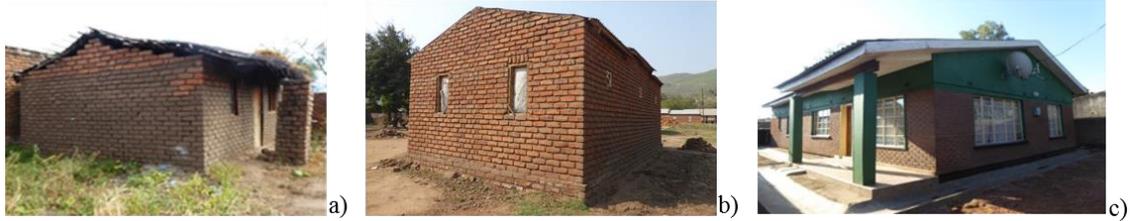
According to the collected data described above, inspected buildings, as illustrated in Table 1, are classified in three typologies: A, B, and C (shown in Figure 3) introduced in the World Housing Encyclopedia by the authors [9, 13] Typology A is representative for 20% of the inspected buildings, characterized by low seismic vulnerability (Figure 3 (a)). These buildings were made of mud mortar combined with fired bricks of poor fabric quality (see Figure 2(b3)) and unfired bricks from poor to high fabric quality (see Figure 2(a1), (a2), and (a3)). Generally, these houses have smaller building footprints than the typical floor plan of 8 m × 6 m. Most of these houses (17%) have thatch supported by light timber elements, while the remaining are made with metallic sheet roof. Roof structures are characterized by a poor structural detailing (e.g. lack of connection between walls and between the walls and roof).

Figure 3: Typical one-story masonry building in Malawi. a) typology A; b) typology B; c) typology C
