A study of technical, economic and social factors affecting micro-hydropower plants in Nepal

Abstract— Due to slow expansion of the national grid, many rural areas of Nepal depend on micro-hydropower plants to provide electricity to homes and businesses. Micro-hydro turbines are designed, manufactured and installed by small and medium sized enterprises based in Nepal. After a plant is commissioned, its technical and economic operation is managed by selected members of the local community. When problems affect the plant, people are forced to rely on traditional or fossil fuel-based technologies to provide light to their homes, whilst many businesses cannot run without a supply of electricity. A study of 24 sites (18 Crossflow and 6 Pelton turbines) looked to identify the combination of technical, social and economic factors that affect the performance and reliability of plants. Interviews were carried out with plant operators, plant managers, and consumers to understand how the plant is run and managed, and the position it occupies in the local community. A quantitative assessment of maintenance and observation of 10 sub-systems was conducted at each site. The information collected

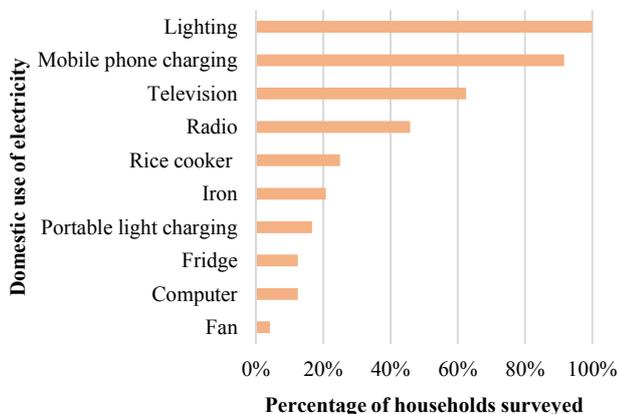
Fig. 1 Domestic uses of electricity

Responses from consumers indicated their domestic electricity uses and the impact they have on their time and expenditure. Fig. 1 shows the electricity uses mentioned and the percentage of consumers using them in their homes.

Lighting and mobile phone charging were the most common domestic uses. Lighting remains the main use of electricity from MHPs since their introduction to Nepal. When problems occurred at their MHP, all of the consumers said that they

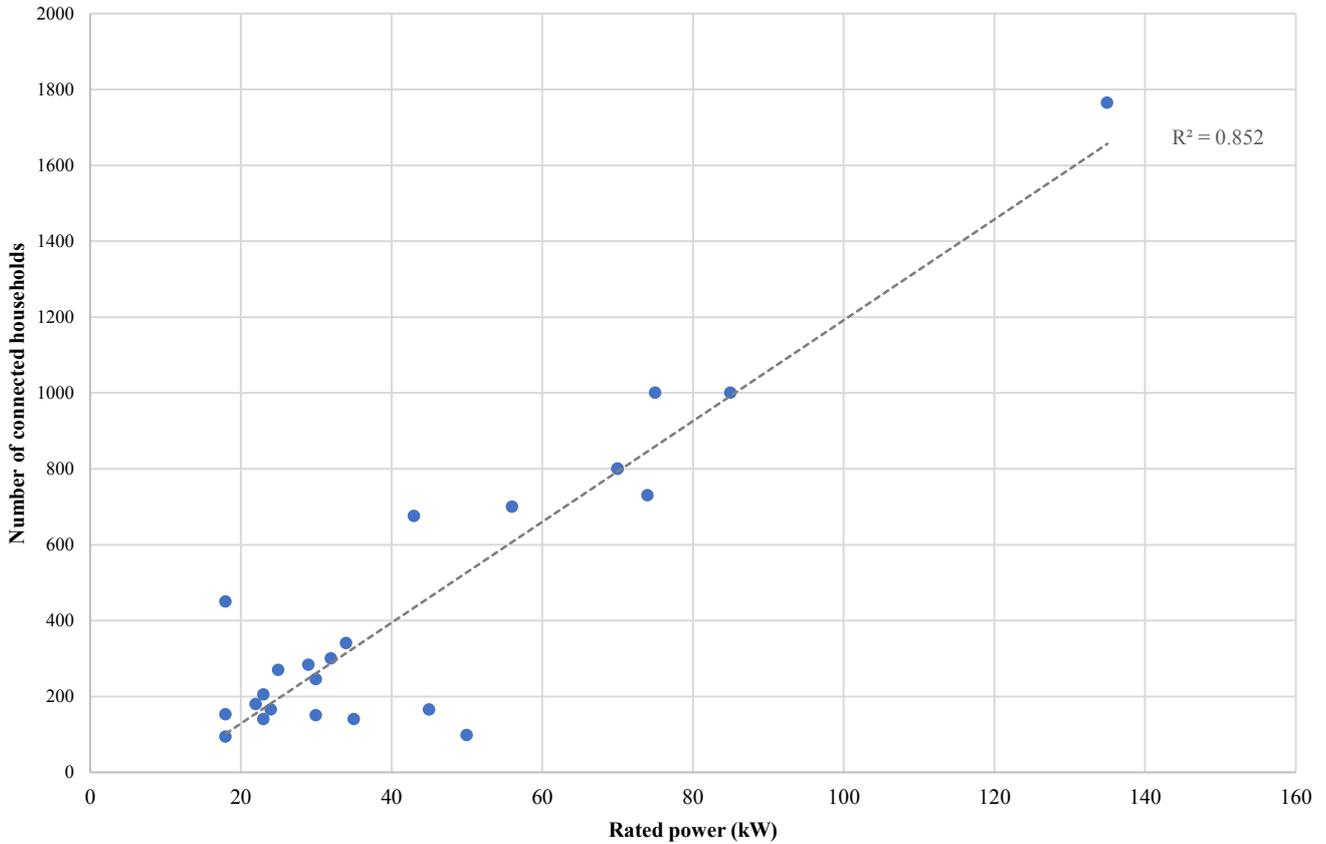
Fig. 2 Number of connected households against rated power

Sustainable plant operation depends on a combination of domestic and commercial uses. Typically, households will use most of the available electricity during the night. This means plants are more likely to be financial sustainable if they have a large number of end uses operating during the day. Fig. 2 shows the number of connected households against the rated power of each site. There is a strong positive correlation ($R^2=0.852$) suggesting that despite the range in rated power of the sites, the household consumption was similar at all the sites. Households are typically added until the full rated capacity of the MHP is in use. The points lying furthest above the linear line of best fit are sites that provide electricity to a large number of dispersed villages on hilltops. These areas tended to be poorer where electricity consumption is lower meaning a greater number of households can be connected. The points lying furthest below the line of best fit are located in valley areas where everyone in the local area has been connected and the cost of line extension to people living higher up is very high.

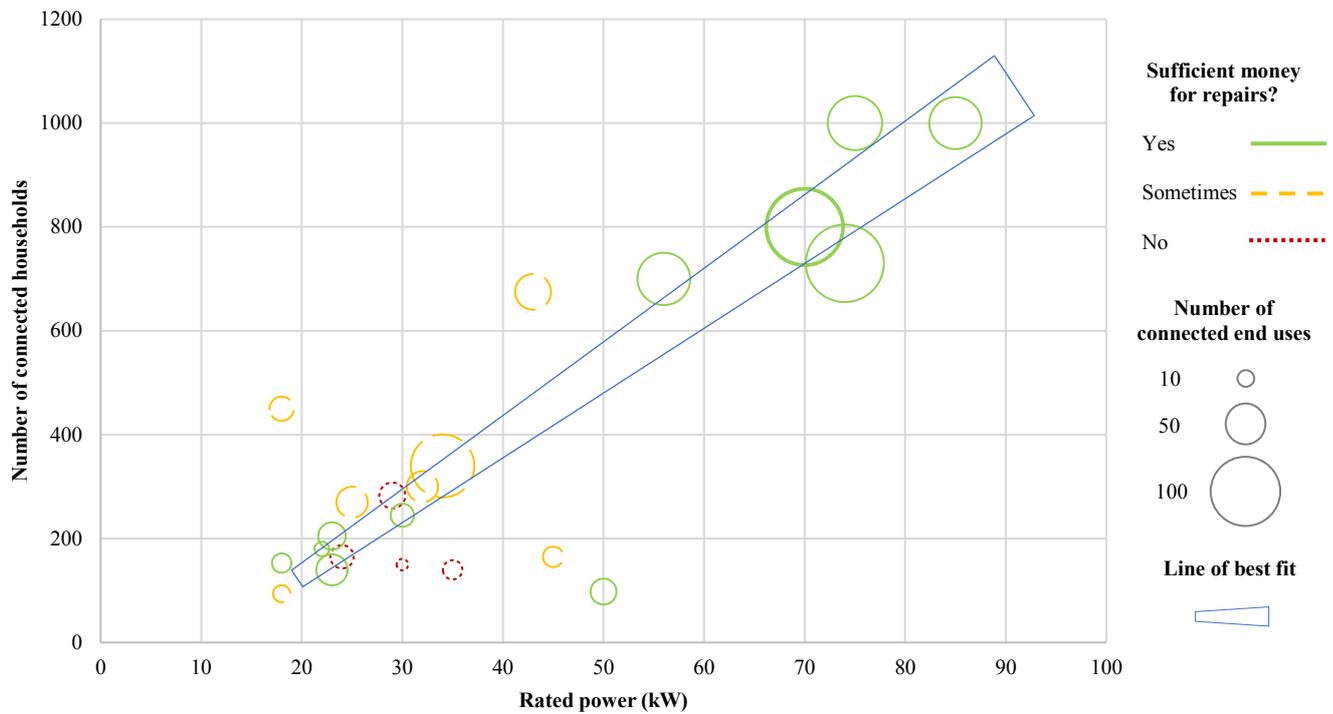
Fig. 3 Number of connected households and end uses against rated power

By adding information regarding the number of connected end uses, it is possible to visually assess which plants may be struggling financially. Fig. 3 shows the number of connected households against rated power, where the area of marker represents the number of end uses that are connected to that MHP. In addition, the markers are coloured according to the manager's response to the following question: "When there

have been technical problems, has there been enough money to pay for repairs?" Responses to this question have been coded as "mostly yes", "sometimes yes/no" and "mostly no". If problems occur and the plant is unable to pay to repair for them, the managing committee must find alternative methods to collect the necessary money. Common approaches by managers included asking beneficiaries for additional money (either as a donation or a loan), taking banks loans or avoiding repairs until sufficient money had been saved. In the long term, it is unlikely that any of these approaches will be sustainable therefore the responses to this question are assumed to give a reasonable indication of the financial stability of each plant. The site with the highest rated power has been removed as its connection to a stone thresher with a typical load of 100kW skews the results in relation to the number of connected end uses. The line of best fit shows the relationship of both connected households and end uses to rated power. The gradient of the line of best fit indicates the relationship between rated power and number of households. The width of the line (at a given rated power) indicates the expected number of connected end uses. Both relationships are assumed to be linearly correlated to rated power with R^2 values of 0.676 and 0.465 for households and end uses respectively. There are 2 markers which overlap on the graph as they both have rated powers of 70kW, 800 connected households and a similar number of end uses.

The addition of the number of end uses provides a snapshot of which plants may be performing better financially in comparison to others. The vertical position relative to the line markers relative to the line of best fit can indicate whether the number of connected end uses is greater or lesser than the trend. The size of the marker relative to the width of the line of the best fit can indicate whether the number of connected end uses is greater or lesser than the trend. Considering the colour of the markers, the plants rated above 50kW tended to have less problems in paying for repairs. More commercial opportunities provide a higher non-domestic income. The larger sites were providing electricity to towns where there is also greatest demand for household connections. The higher rated capacity also permits the connection of high load uses that have a current draw which smaller MHPs would be unable to manage.

One would expect that if a site is below the line of best fit, it would struggle to pay for repairs unless it has a large number of connected end uses to generate sufficient income. This assumption is corroborated by the 2 “no” markers at 30kW and 35kW and the “sometimes” marker at 45kW. However, the “yes” marker at 50kW has a small number of household and commercial connections but has always been able to pay for repairs. The end uses connected to this site include 2 flour mills, 2 furniture makers, 2 mobile phone masts and a poultry farm. These end uses are all high load applications and are likely to be reliable customers due to a high demand for their services. For consumers, the site’s tariff structure had the lowest minimum allowance of any site (NPR 100 for 4kWh), meaning most consumers would be exceeding the lower limit. Technically, this plant was very well maintained and was the

Sites positioned above the line of best fit can potentially afford to have fewer end uses due to their greater number of connected households. However, the “sometimes” markers at 19kW and 43kW indicate sites where this is not the case. These sites have heavily dispersed consumers whose electricity consumption may be lower. The 43kW site has consumers distributed over a wide area so that tariff collection is completed on a 6 monthly basis. Another factor of beneficiaries covering a larger geographical area is the need for longer transmission lines. The plant manager of the 19kW site explained that the transmission lines were prone to blowing down in the wind which adds an additional cost that other sites may not regularly incur. The geographical information regarding these sites helps to explain why they have experienced problems in paying for repairs.

By combining information regarding the number of connected households and ends uses with the responses of plant managers, Fig. 3 provides an impression of plants which may be struggling financially. Of the 4 sites significantly below the line of best fit, 3 had faced issues in paying for repairs. However, the graph does not account for the load of end uses connected, geographical nature of the plant nor the technical and financial management of the plant.

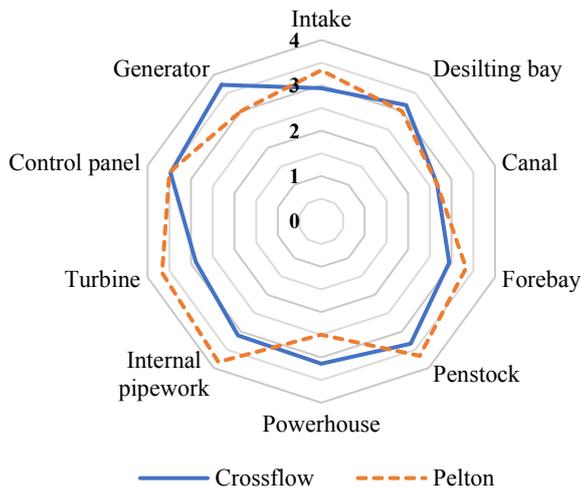
Fig. 4 Crossflow and Pelton maintenance results (out of 5) for 10 sub-systems

The mean results (out of 5) were 3.3 for Pelton turbines and 3.1 for Crossflow turbines. Fig. 4 shows a comparison between Pelton and Crossflow turbines of the average maintenance score for each of the sub-systems using a radar chart.

The largest difference was in the maintenance of the turbine sub-system, where Pelton types outperformed Crossflow types. Many of the Crossflow turbines had leakage from their casings at the shaft bore. This was less common amongst the Pelton turbines, suggesting that different sealing systems were in use.

There was a similar difference for the internal pipework where leakage was more at the Crossflow sites. As Pelton turbines have smaller flow rates, leakage has more impact on power output. Less leakage in Pelton turbines suggests greater care taken by manufacturers to minimise this effect. For both turbine types, mean scores for all of the civil sub-systems received similar scores. The weakest sub-system amongst both types was the canal. Many of the canals were longer than 1km with some almost 3km long. For the operator, this results in a considerable amount of work. Often the canals are also affected by landslides or damage due to vegetation, particularly in overgrown jungle areas.

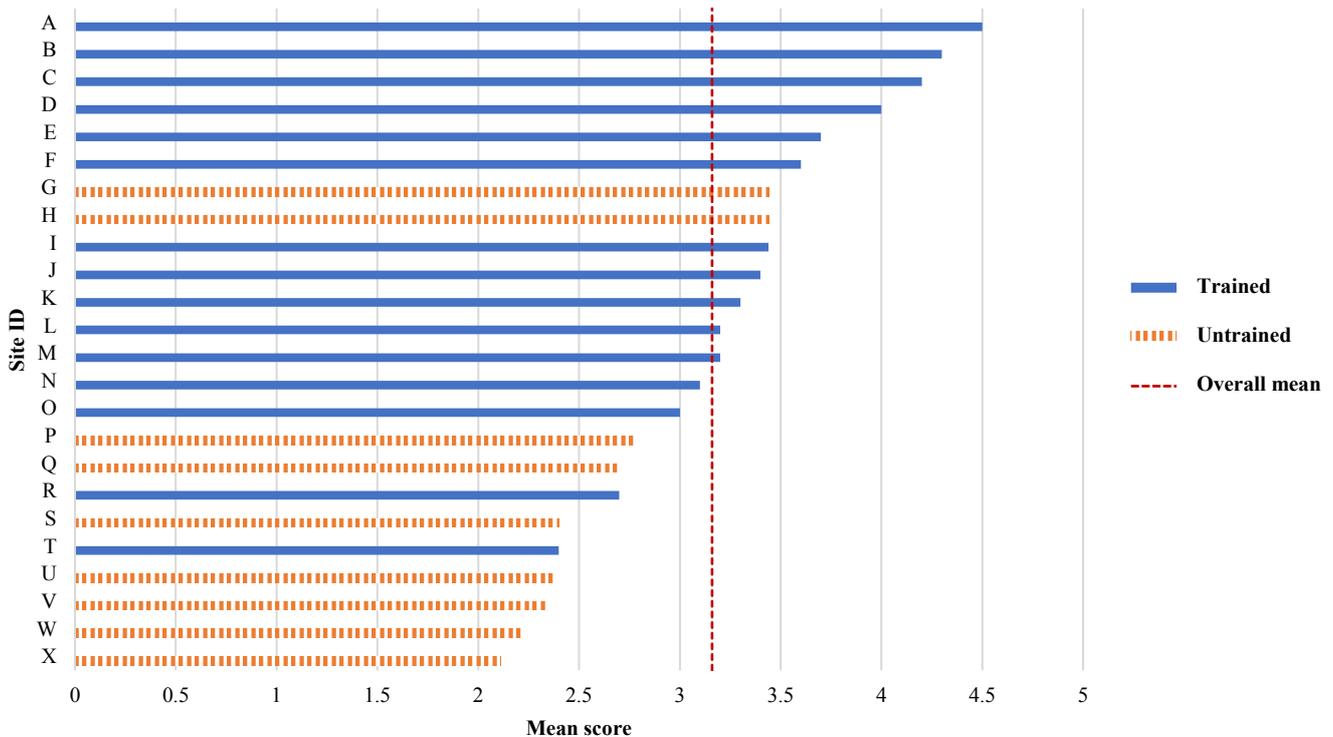
Fig. 5 Mean scores by site

Fig. 5 shows the mean scores of sub-system assessments by site for trained (solid bars) and untrained (striped bars) operators. The vertical dashed line is the mean of all the sites. 7 of the worst 9 sites are those with untrained operators. Sites G and H are the 2 exceptions which achieved a higher standard of maintenance. Site G had a particularly good standard of maintenance inside the powerhouse. In the interview with the plant operator, it was explained that the turbine runner had been replaced 3 months ago by technicians from an engineering company which may have made it easier to preserve a good standard of maintenance since then. Site H also had a good quality of maintenance inside the powerhouse. The plant operator said that he liked his job as it was a “social contribution”. Sites R and T were sites with trained operators that had a poor standard of maintenance. Both plants were connected to over 1000 households and ran for 24 hours continuously. Their operators explained that Site R stopped

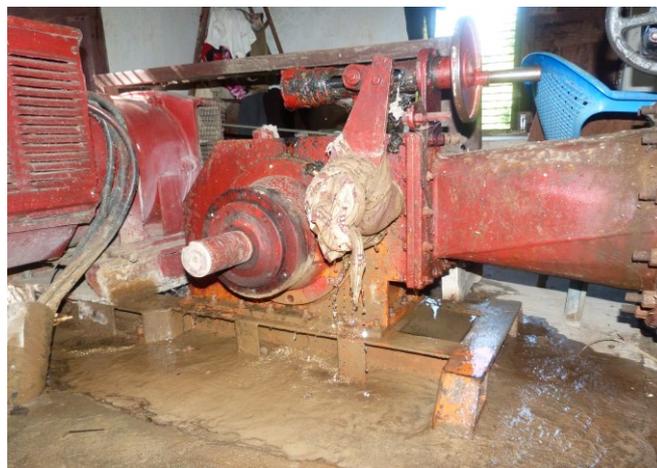
At sites with untrained operators, it was found that the inside of control panels often had loose cable clamps and wires pulled from their conduits. For both the internal pipework and turbine, leakages, rust and loose bolts were common as shown in Fig. 6. All of these issues suggest a lower level of knowledge or ability and a lack of care or time. It is noticeable that the 3 sub-systems with greatest difference between the two groups are all inside

Fig. 6 Leakage from turbine casing

repair or replace parts sooner. Another issue is water leakage from turbines. Turbine manufacturers are responsible for developing an effective sealing system and poor design could prevent this. Conversely, inaccurate manufacturing of a good design could also result in a leaking system. During installation, it is the responsibility of the manufacturing company to ensure that the turbine casing is properly sealed. Over time, a system may begin to leak and the operator should be responsible for preventing it by ensuring O-rings and gaskets are correctly seated and bolts are tightened. Regardless of when the problem manifests or develops, leakage results in a lower power output due to a loss in pressure. Similarly, issues with alignment (which were witnessed as large vibrations in transmission belts) can also manifest themselves in a number of stages. As a mechanical system, vibrations in the system will cause movement which alters alignment and changes the belt tension. During operation, the plant operator is responsible for correcting this issue, but it is possible that poor design and manufacture lead to it. All of the issues listed in Table 5 have an impact on the turbine when in operation and should be addressed by the operator accordingly. However, for many of these problems, greater attention to detail in an earlier stage of the project can minimise their affect. For example, manufacturing bearing housings and shafts to tolerances as recommended by the bearing supplier will minimise the possibility of shaft vibration.
