Paul, A., Xu, X., Wisnom, M. R., & Shimizu, T. (2019). *The Effects Of Environmental Conditions On The Strength Of Double Lap Joints*. Poster session presented at 22nd International Conference on Composite Materials, Melbourne, Victoria, Australia.

The Effects Of Environmental Conditions On The Strength Of Double Lap Joints

The strength of double lap joints for increasing overlap lengths at Room Temperature Dry (RTD), Hot Temperature Dry (HTD) and Hot Temperature Wet (HTW) conditions was studied. The failure mechanisms were identified and material characterisation tests were conducted to understand the joint performance and changing failure modes.

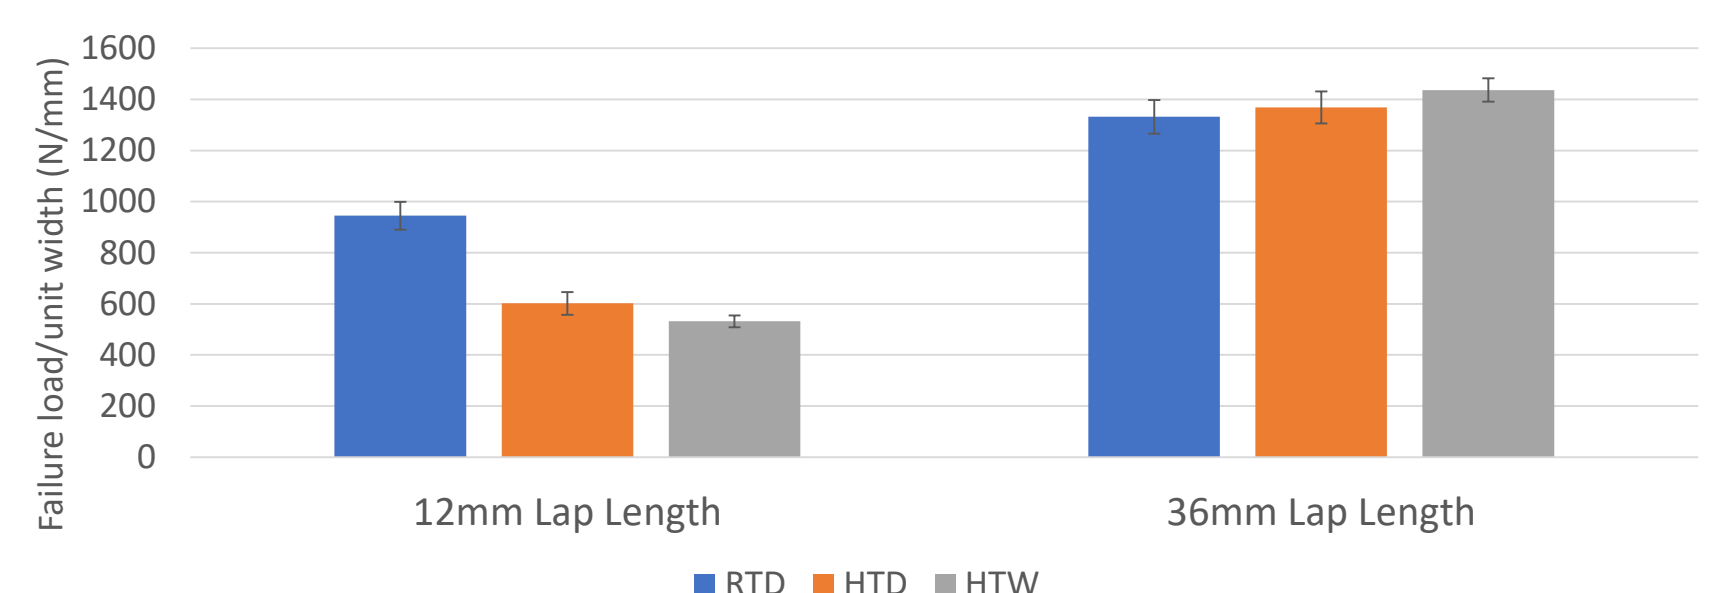
Double Lap Joint Results

- **12 mm overlap length:** Significant decrease in failure load as the failure was controlled by the shear strength
- **36 mm overlap length:** No significant difference in strength - Fracture dominated for all conditions - G_{IC} increases and G_{IIC} decreases

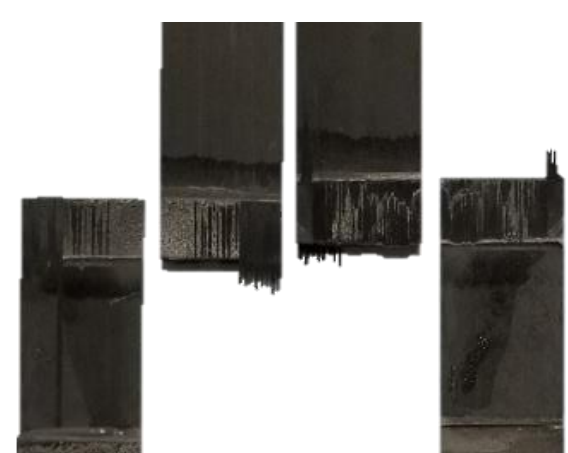
- **12mm Overlap Length** – Patches of adhesive on fracture surface as failure was controlled by adhesive strength
