Manandhar, V., Shrestha, H., Marasini, N. P., Prajapati, R., Guragain, R., Chaulagain, R., Sextos, A., Alexander, N. A., De Luca, F., & Giordano, N. (2020). *EXPERIMENTAL INVESTIGATION OF LOW COST STEEL WIRE MESH RETROFIT FOR STONE MASONRY IN MUD MORTAR*. Paper presented at 17th World Conference on Earthquake Engineering, Sendai, Japan.

## EXPERIMENTAL INVESTIGATION OF LOW COST STEEL WIRE MESH RETROFIT FOR STONE MASONRY IN MUD MORTAR

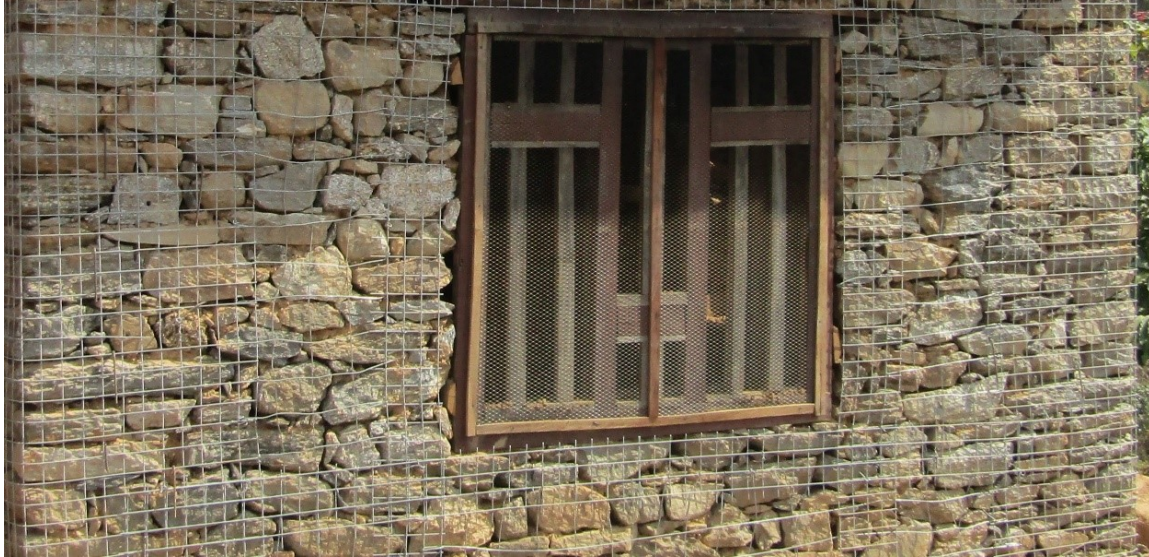
Figure 1 A house with WWM laid over and ready for plaster

The steel Welded Wire Mesh (WWM) is applied as per design on the designated structures. Splints and bandages are typically designed alongside openings and portions of the masonry as required by design. At other locations, Galvanized Iron (GI) wires placed farther apart are provided to prevent local failure of masonry and prevent spalling of masonry units. Through wires or semi through connectors are provided on the walls at certain intervals in a staggered fashion, tying the inner and outer meshes together. Plaster of 20mm and 30mm thickness is applied at the inner and outer face respectively to protect the mesh from corrosion. A reinforced concrete tie member is provided at the base of the walls to ensure fixity. The general process in implementation of retrofitting work using steel wire mesh includes 1) Removal of existing plaster from walls in the proposed area 2) Raking out mortar joints to 15-25 mm depth, cleaning and wetting the surface 3) Excavating the soil for tie beam and laying the reinforcement 4) Applying the WWM on walls and providing anchor rods or

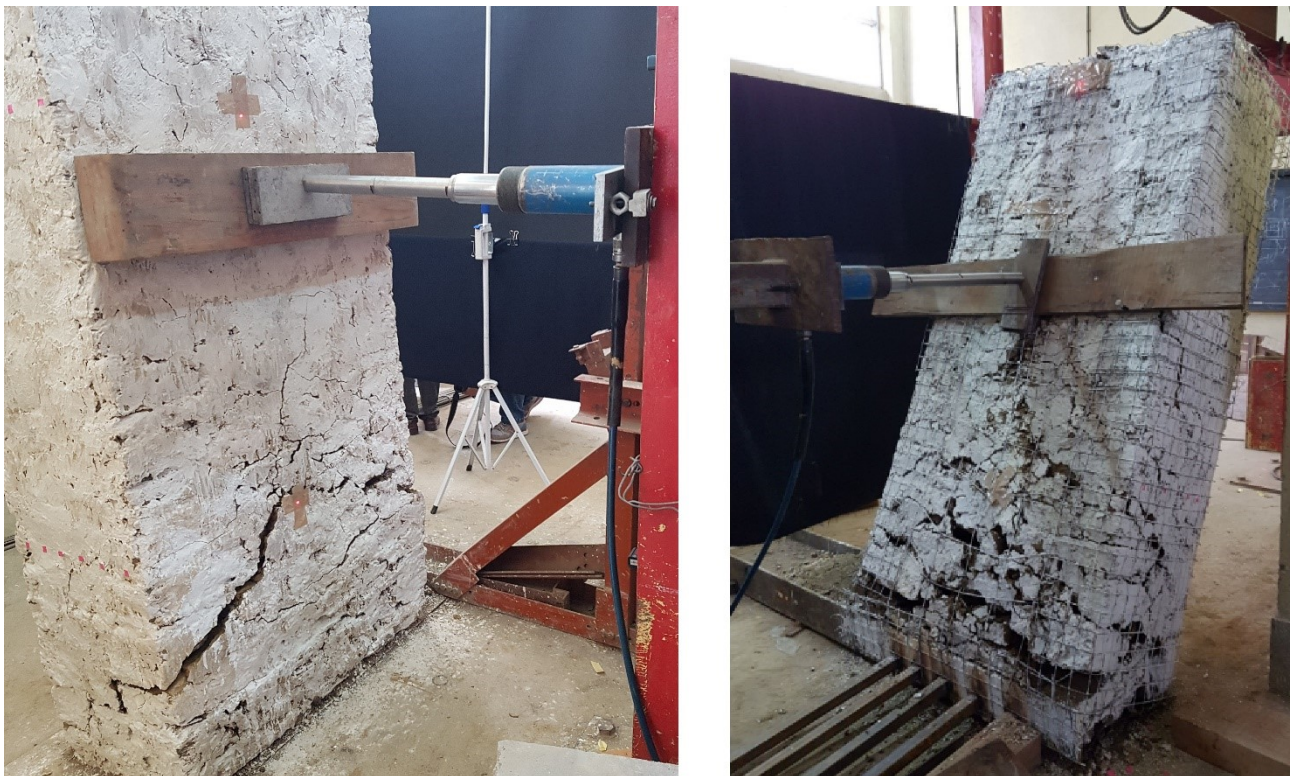
Figure 5 Damage Pattern on the unretrofitted (left) and retrofitted (right) wall

For the unretrofitted wall, the first observable crack appeared at a height of 0.33m at a top deflection of 49 mm. The crack propagated to form a peak shape across the length of the wall on the tension side (refer Figure 5). The damage suffered was highly localized to the region. Due to the limitation of the arm length of the hydraulic jack, the test had to be halted momentarily at multiple occasions when the arm had to be replaced with successive longer ones. At these points, the wall experienced unloading. The wall failed after suffering a maximum top deflection of 321mm at 4.07 KN.

For the retrofitted wall, cracks were more distributed throughout the lower half of the wall. The first observable crack occurred at a top displacement of 67mm. Collapse of the wall finally occurred due to the failure of the bottom GI wires spaced at 150mm spacing along with the vertical wires of splints. The final top deflection suffered before collapse was significantly improved to a value of 769mm at 7.27 KN. These load values were calculated after correcting the error from the analog dial using a digital load cell. Therefore, the absolute value may not be reliable although the figures give a good idea of the relative enhancement in strength.

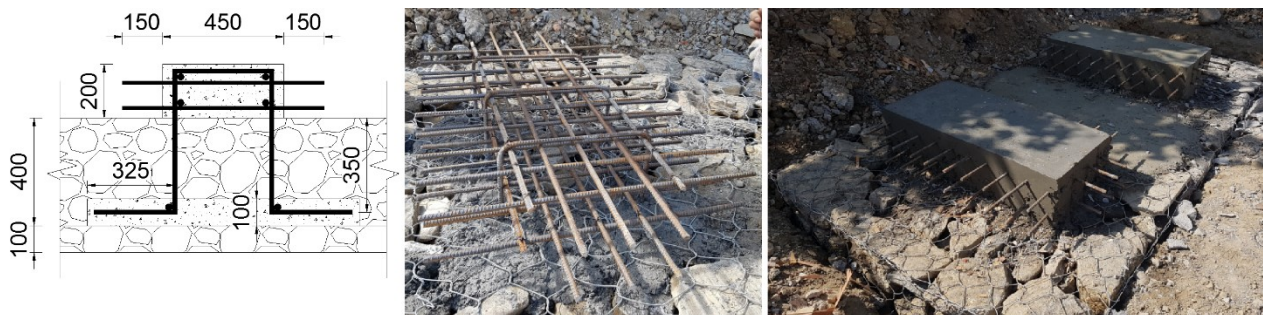
Figure 7 Cross section of the RC pedestal (left); Laid rebar before casting (mid); Casted RC Pedestals (right)

A 400mm thick raft-like stone foundation was constructed that prevented any kind of uplifting. Two M20 RC pedestals were designed to serve as a base for each wall. Multiple protruding rebar were left out for the wire mesh to be connected. The transverse U shaped rebar of the pedestal were continued to the base of the foundation and anchored with 100mm thick M20 concrete (refer Figure 7).

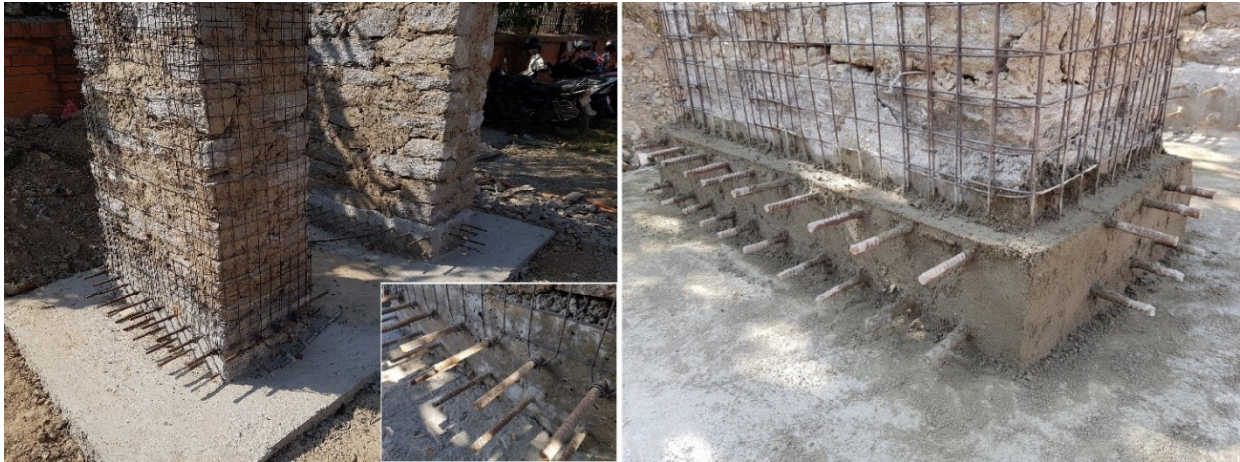
Figure 8 Wire mesh tied and welded to the rebar of the pedestal (left); Connections covered with 50mm of 1:6 plaster (right)

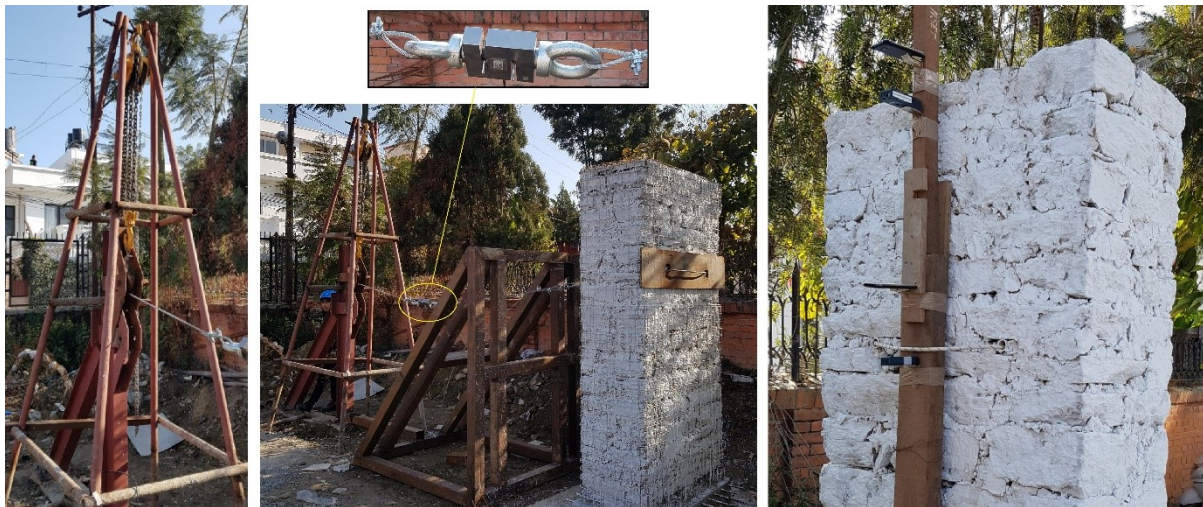
Figure 9 Chain pulley arrangement (left); Pulldown setup for retrofitted wall (mid); Lasers placed pointing towards the retrofitted wall, using the unretrofitted wall as support (right)

A support frame was placed beside the retrofitted wall catering to the need of protecting the load cell and due to safety concerns. Learning from the pilot test, it was anticipated that the retrofitted wall would fail as a unit instead of disintegrating into smaller chunks. Therefore, the need for the support frame was realized. The distance of the support frame was carefully selected so that the retrofitted wall rested on the frame only after suffering complete failure.

High strength steel cables of 10mm diameter were used for pulling, forming loops through and around the walls and around the eye bolt ends of the load cell. The chain pulley was setup in such a way that the upward movement of the hook end would be translated to a horizontal pulling movement via a grooved wheel, connected to the reaction frame (also refer Figure 6). The chain pulley was operated by hand by a technician under the supervision of a structural engineer to maintain a uniform rate of displacement. The least count of the load cell was 0.01KN and that of the laser was 1mm. The test walls were painted white for better visibility of the cracks.

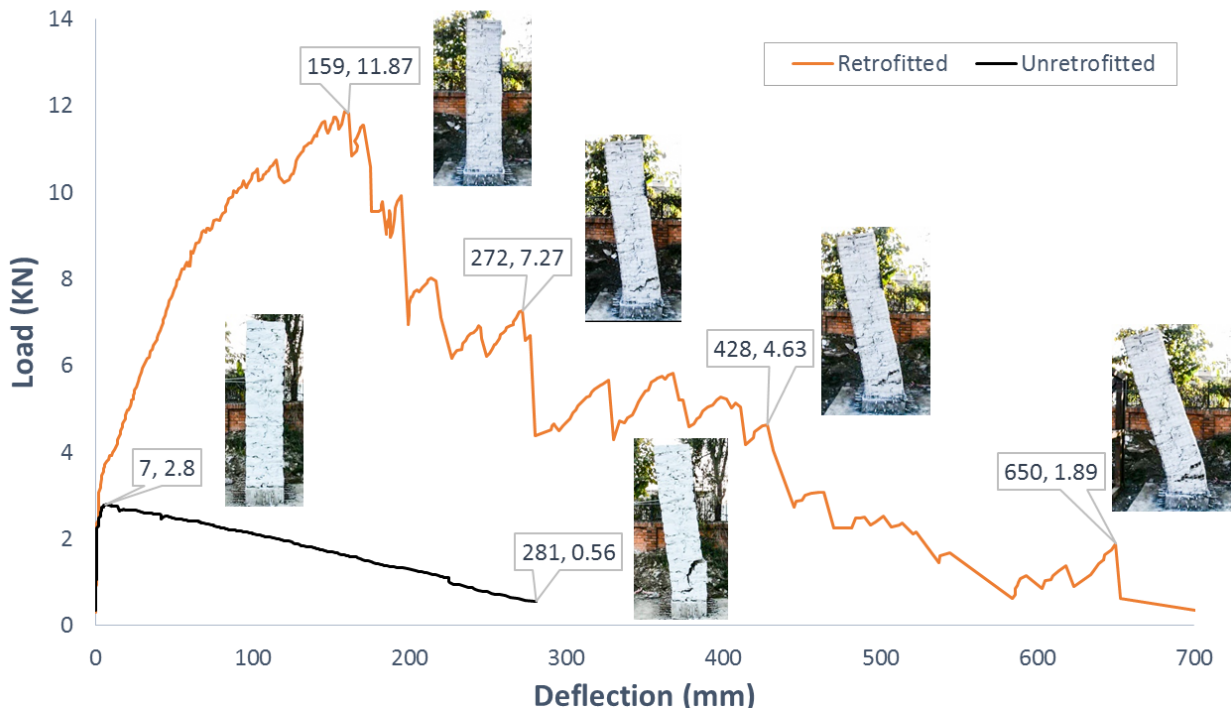
Figure 10 Load vs Displacement curves of the Retrofitted and Unretrofitted walls (pictures correspond to the top deflection and load values to their immediate left)

The maximum load for the retrofitted wall was 11.87KN, which was 2.8KN for the unreinforced wall. Similarly, the final top deflection improved to 650mm from 281mm, upon retrofitting. The load vs displacement curve obtained after integrating load and displacement data is shown below:

Both the walls exhibited a high stiffness on initial loading with both walls withstanding a load of 2.5KN within 1 mm of deflection. For the unreinforced wall, peak load of 2.8KN was reached at 5 mm of deflection, after which the load displacement curve suffered a smooth downward decline. The cracks were highly localized with major ones appearing on the tension side at a height of 0.5m. Upon increasing the load, the horizontal crack propagated to the front-lower level up to the interface between the lowermost and second lowermost stone unit (refer Figure 11). The average rate of top displacement for the unreinforced wall was 0.7 mm/sec and the loading increased at an average rate of 0.01KN/sec till the peak load.

For the retrofitted wall, the high stiffness continued till a loading of 3.75KN (6mm deflection), after this the stiffness decreased slightly till a loading of 8.25KN (56mm deflection). The curve is smooth up till this point after which, minor undulations can be seen on curve. The undulations are because of the stone layers slipping at the unit-mortar interface. The curve rises to its peak load of 11.87KN at a deflection of 159mm. At this point, clear visible cracks had formed at a height of 0.25m (1/8<sup>th</sup> the height of the wall). The curve follows an overall downward trend after this point. Sharp falls and rises follow, where peaks can be seen when different parts of the mesh is activated one after another. Sharp falls can also be seen when the mesh wires yield, causing the welds to break, activating other consecutive regions of the mesh. The most yielding was observed at the connection between the GI wires spaced at 150mm c/c and the lowermost horizontal band, where the welds of topmost horizontal wires of the bands had broken. This happened because the GI wires spaced at 150mm c/c were not fixed to the pedestal rebar and were tied to the horizontal band. In the actual field condition, these wires are anchored to the rebar of the RC tie beam. Ultimate failure of the wall took place at a top deflection of 650mm (1.89KN) caused due to the failure of wires of splints. The average rate of top displacement for the whole loading sequence was 1mm/sec and the loading increased at an average rate of 0.05KN/sec till the peak load.

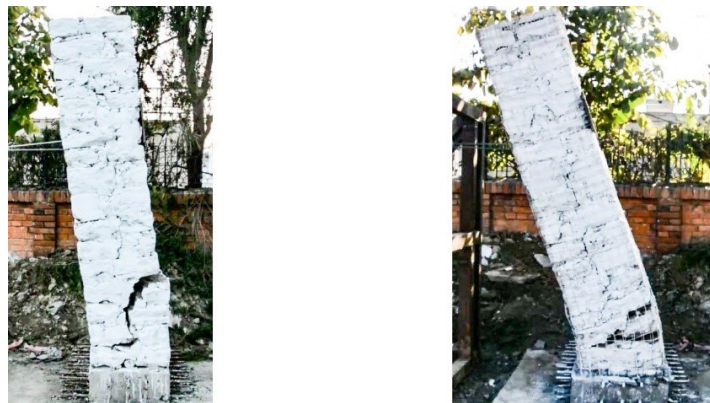
Figure 11 Final deflected shape of the unreinforced (left) and retrofitted (right) wall before collapse
