A study of micro-hydropower plants in Nepal:

Sustainability from technical, economic and social perspectives

Abstract— Micro-hydro power provides electricity for homes and businesses in rural areas across Nepal. Technical, economic and social problems can all affect a micro-hydro plant's capacity to provide a consistent and reliable supply of electricity. A study of 17 sites in Nepal investigated the quality of maintenance and installation, management practices, and perspectives on micro-hydro plants. A visual assessment of sites was used to quantify the quality of maintenance and interviews were used to understand the roles and attitudes of plant operators, plant managers and consumers. The results showed successful management structures were in place at all sites and plants with trained operators tended to meet a higher standard of maintenance. However, technical issues that develop before and after a turbine's commissioning can threaten the technical and economic sustainability of plants.

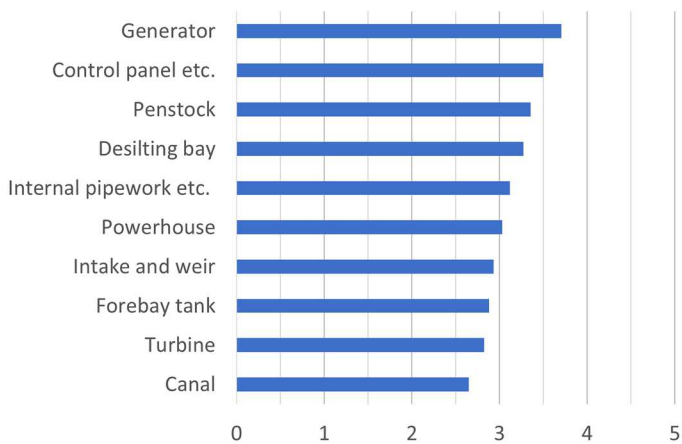
Fig. 3. Mean maintenance score by sub-system

Fig. 3 shows the mean maintenance scores for each of the sub-systems. The 3 worst performing sub-systems were the canal, forebay tank and the turbine. It was observed that canals were often cracked with vegetation overhanging or growing from the walls. Many forebay tanks had dirty trash racks and debris in the bottom of the tank. Turbines scored low due to leakage from the casing and evidence of over-greasing. Responses in interviews supported these observations, more than half of operators said that they cleaned the trash rack less than once a day whilst 11 of the 17 operators said that they greased bearings more than once a month. Both responses indicate that plant operators were performing these tasks at incorrect intervals for a typical micro-hydro scheme [5].

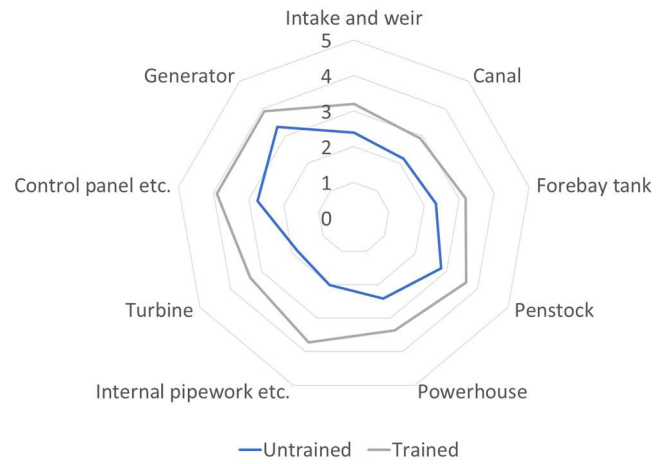
Fig. 4. Mean maintenance score by sub-systems for trained and untrained operators

Fig. 4 shows a radar graph which compares the average maintenance score for each sub-system for trained and untrained operators. The mean averages across all sub-systems were 3.5 for trained operators and 2.5 for untrained operators. The results for the desilting bay have been omitted as only 1 of the sites with an untrained operator had a desilting bay. Fig. 2 shows that 5 of the 6 worse sites had untrained operators.

The 3 sub-systems with greatest difference between trained and untrained operators were all located inside the powerhouse. On these sub-systems, by failing to complete daily maintenance tasks such as cleaning or addressing persistent issues such as leaking, a long-term lack of maintenance becomes more obvious. In general, these results are encouraging for the organisations delivering operator training in Nepal. This study demonstrates that training is effective in delivering a higher quality of maintenance.

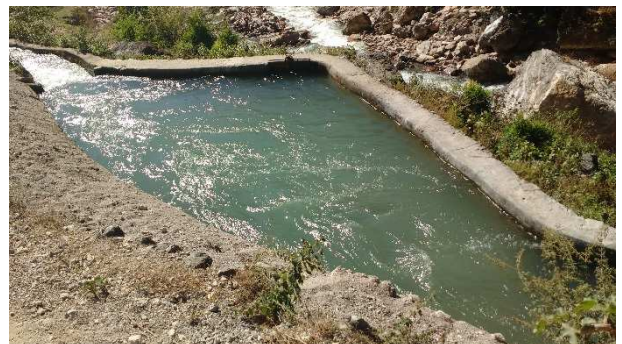
As well as the variability in maintenance quality, a large variation in construction quality was also witnessed. Often located on steep banks, many canals were impressive constructions. In several locations, caves had been hollowed to allow a canal to pass through. The construction of desilting bays and forebay tanks was often poor and ineffective in removing silt, see Fig. 5. It was often seen that water entered bays too quickly or tended to flow along one wall. The shape of a desilting bay is critical to reducing flow velocity and allowing silt to settle. When there is high silt content in water passing through the turbine, there is more damage resulting in a requirement to replace parts more frequently.

Fig. 5. Ineffective shape of desilting bay

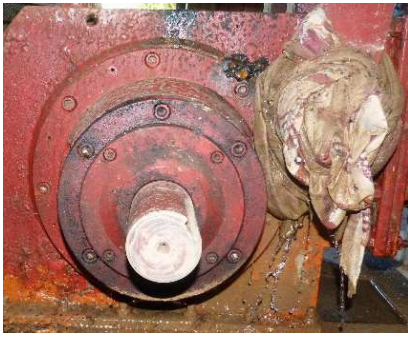
Fig. 6. Leakage from turbine casing

The construction of turbines was generally satisfactory, however, leakage from internal pipework and turbine casings was common, (see Fig. 6). The loss of pressure associated with leakage affects performance and for smaller systems could significantly reduce the available power. It was also seen that many transmission belts were running with large vibrations. During the interviews, 7 plant operators indicated that turbine

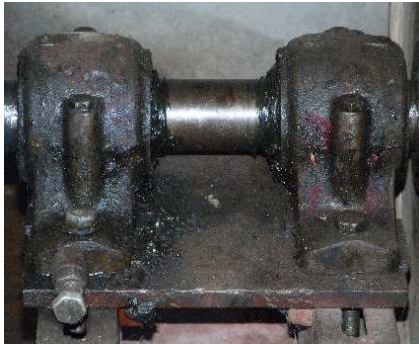
Fig. 7. Over-greasing of turbine bearings

bearings had broken in the previous year. Operators seemed to be prepared for this; interviews revealed that turbine bearings were the most commonly kept spare part. Although belt vibration and over-greasing were observed (see Fig. 7) other factors contributing to bearing failure such as belt wear and misalignment in shafts could not be assessed without turbine disassembly. Both leakage and bearing failure require further investigation to understand whether they are design, manufacture, installation or maintenance issues.
