Novelli, V., Ngoma, I., Kloukinas, P., Kafodya, I., De Risi, R., Macdonald, J., & Goda, K. (2019). *Seismic Vulnerability Assessment of Non-engineered Masonry Buildings in Malawi*. Paper presented at 7th International Conference on Computational Methods in Structural Dynamics and Earthquake Engineering , Crete, Greece.

SEISMIC VULNERABILITY ASSESSMENT OF NON-ENGINEERED MASONRY BUILDINGS IN MALAWI

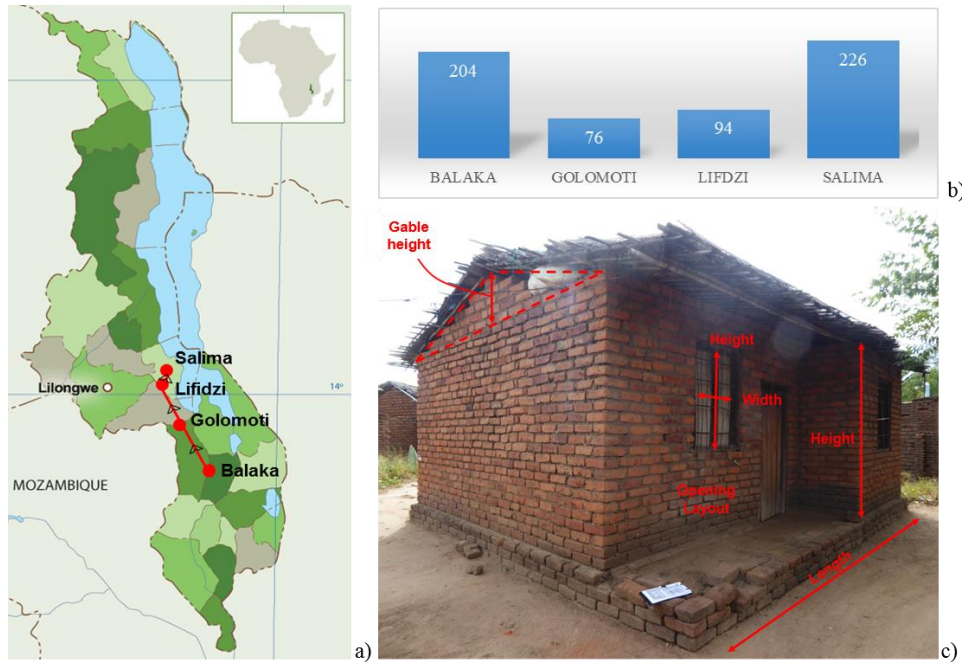
Figure 1: a) Building survey locations, Balaka, Golomoti, Lifidzi, and Salima; b) number of façades collected for each site c) geometrical measurements collected for each inspected façade
