COLUMN INTERACTION IN TUFTED SANDWICH STRUCTURES UNDER EDGEWISE LOADING

Jamie W. Hartley*, Gavin Tse, James Kratz, Carwyn Ward and Ivana Partridge

Keywords: 3-Dimensional Reinforcement, Sandwich, Mechanical Testing, Tufting

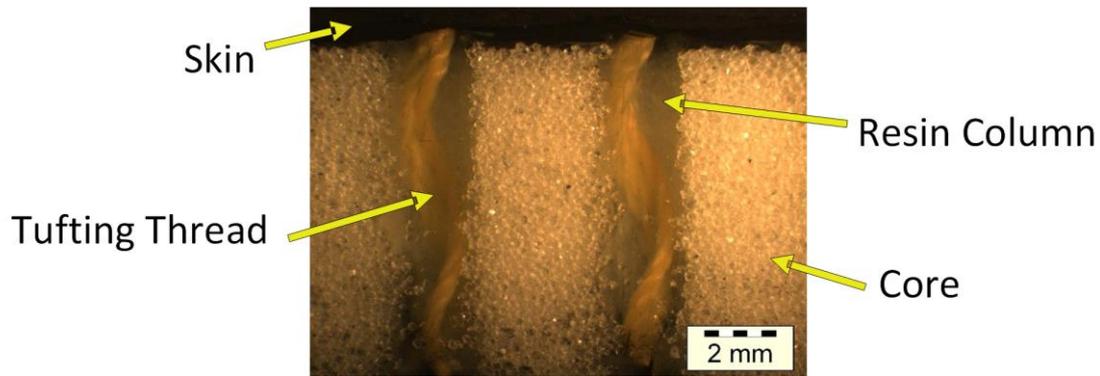
One of the notable features of tufting sandwich panels is the relatively large column of resin formed around the tufts (Figure 1). This is due to the brittle nature of the foam core, which fragments and leaves behind a void after needle insertion. As the needle used (~2 mm) is typically much larger than the tufting thread (~0.3 mm), a void is left within the core that fills with resin during infusion of the part.

Figure 1. Resin columns formed during tufting.

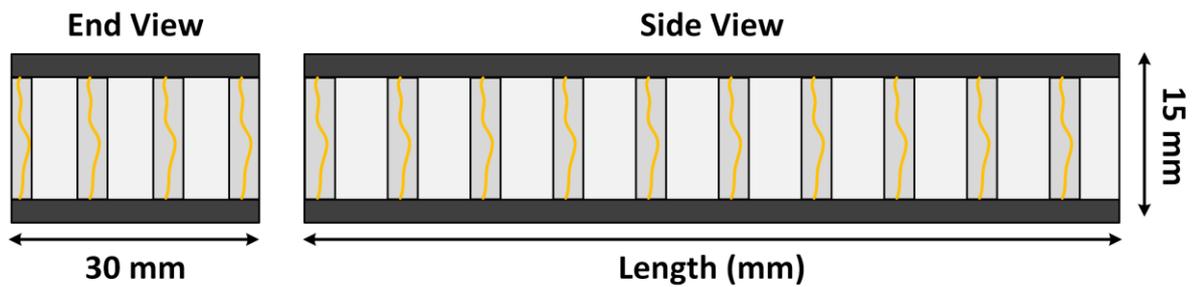
After cure the test coupons were cut using a diamond saw to the dimensions shown in Figure 2. The length of the test coupon was varied to provide differing numbers of tufts, creating 3 different coupon configurations. A further set of untufted baseline samples were also created for comparison. A small amount of polishing, using a Buehler MetaServ 250 polishing machine, was carried out on one surface of each coupon to reveal the tuft columns at that face, to allow them to be tracked.

Figure 2. Test coupon dimensions.

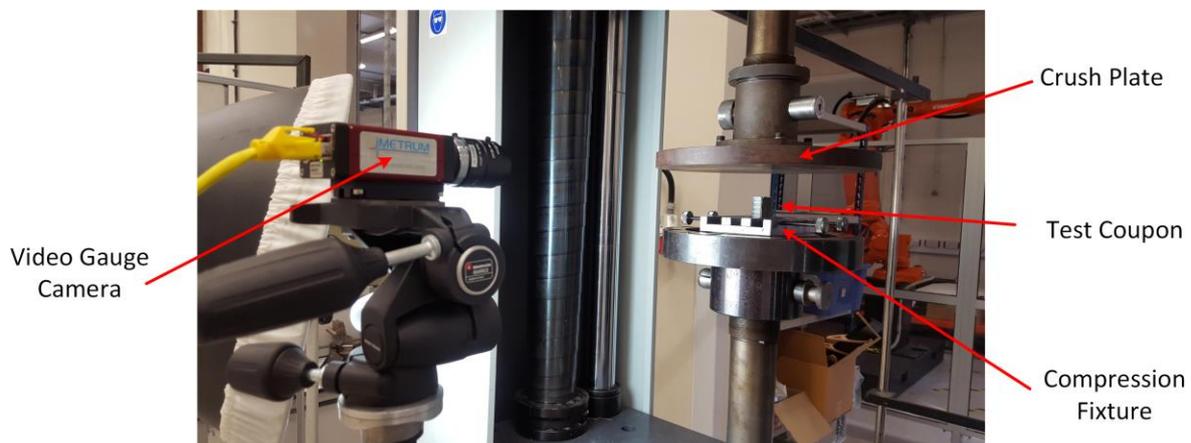
Testing was carried out under quasi-static loading conditions using a Zwick 1466 test machine. Coupons were clamped at the base within an end support fixture, and positioned at the centre of the loading plates, to ensure failure occurred at the free end of the coupon. Coupons were aligned such that the long edge was parallel to the crushing direction, with the polished face exposed for tracking. A displacement control program was used to provide a constant quasi-static crushing rate of 2 mm/min. Testing was terminated after crushing had reached the final tuft before the fixture. A total of 3 coupons were tested per configuration. An Imetrum[®] video gauge system was used to track the movement of the tuft columns at the edge of the coupon. This camera system was able to track the movement of individual pixels within an image, thus following the movement of the tufts as the coupon was crushed. White paint marks were placed on each tuft to act as clear tracking points. The system also allowed video playback of test, allowing failure mechanisms to be viewed and identified.

Figure 3. Test setup.

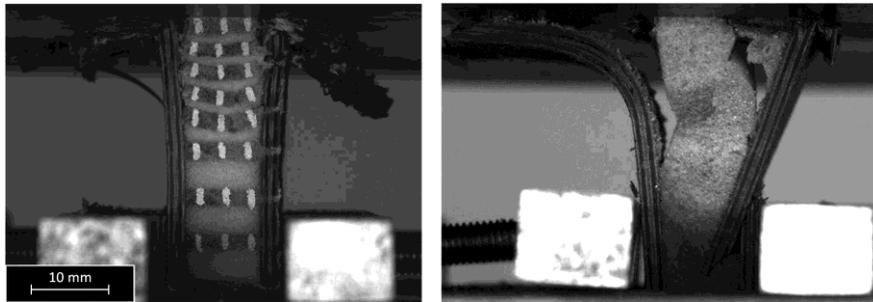
Results of the testing showed a clear difference in failure mode between the tufted and untufted coupons. Failure of the untufted baseline coupons exhibited an unstable collapse, due to global buckling of the coupon as well as separation between the skin and core. In contrast, the tufted coupons predominantly showed a more stable, progressive splaying mode. These failure modes are what would typically be expected for sandwich structures during crushing, as discussed in [1]. The contrasting failure modes are shown in Figure 4.

Figure 4. Failure mode comparison, **Left:** Stable crushing in tufted samples. **Right:** Unstable collapse in baseline samples.

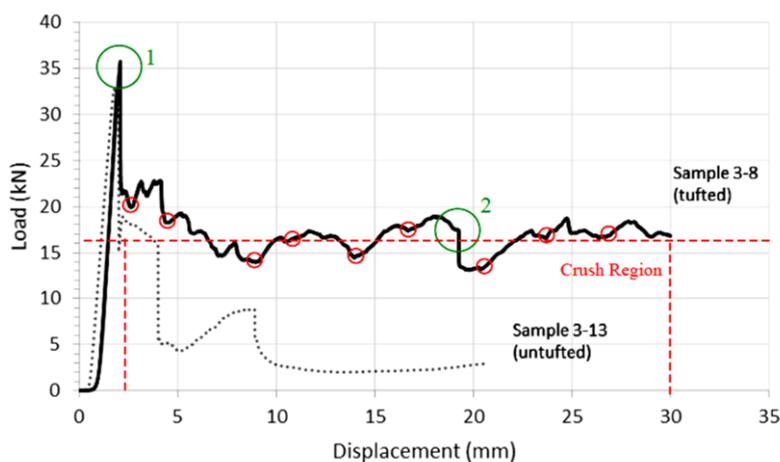
Figure 5 represents a typical load-displacement curve for tufted and untufted coupons, highlighting the difference in performance between the two. Both coupon types show a typical loading response for composite structures during crushing, a sharp peak followed by a sustained crushing force, as outlined in [8]. For the untufted coupon, the load peaks at 35kN (region 1), followed by a significant drop to around 5kN as the coupon collapses. This loading is sustained until around 20 mm of displacement where the coupon fails completely and the test is stopped. Whilst the tufted coupon peaks at a similar load value, in contrast the coupon is able to sustain a much greater load, around 50% of the initial peak. The tufted coupon is also able to sustain the load over a longer crushing distance, showing an increase in length of at least 50%, with the potential for more, as testing was terminated at the fixture, before complete failure of the coupon. Region 2 in Figure 5 highlights a significant drop in load of the tufted coupon. At this point, a relatively large crack appeared at the skin-core interface and resulted in a kinking and fracturing of the skin. However after this drop the tufts allow the coupon to recover the load again.

Figure 5. Representative load-displacement plot of a tufted and untufted test coupon.

Further to the column motion, a number of local failure mechanisms around the tufts were also observed at various stages of the crushing process (Figure 9). These were typically highlighted within the load-displacement traces of the individual tests, as shown in Figure 5. The red markers on the tufted curve highlight the point at which the individual tufts are failing. After each point there was a noticeable increase in the load as the column detached and was forced downwards into the core. These additional failure mechanisms will be explored in more detail in the follow section.

Table 2 shows the specific energy absorption values calculated for each coupon. The energy absorption was approximated by integrating the area under the load-displacement curve, and divided by the crushed material mass. As expected by the results in Figure 5, the tufted coupons are able to absorb a significantly larger amount of specific energy, due to the increased load and longer crushing distance. This is despite an increase of the mass due to the tufts.

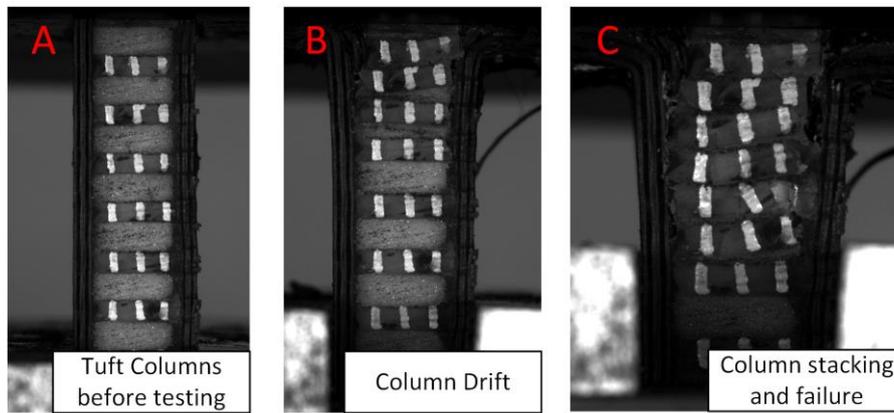
Video tracking during testing showed that in-plane movement of the tufts took place, in the direction of the applied crushing force. As these columns began to drift they would come into contact with each other and began to stack. An overview of this process is shown in Figure 6.

Figure 6. Drift and stacking of tuft columns (white marks used for video tracking).

Tracking of the tufts was carried out both in the direction of crushing and perpendicular to this. Tracking of the in-plane movement (Figure 7) supports the image shown in Figure 6, but also highlights the stability of the process. The tufts appeared to fail at a constant rate with no sudden unstable jumps. On the other hand, the perpendicular displacement showed a change of direction in the movement. This was because one skin would typically fail before the other, which resulted in tuft failure at only one end, pulling the tuft in one direction before it corrected and moved back to its neutral position as the other skin failed (Figure 8).

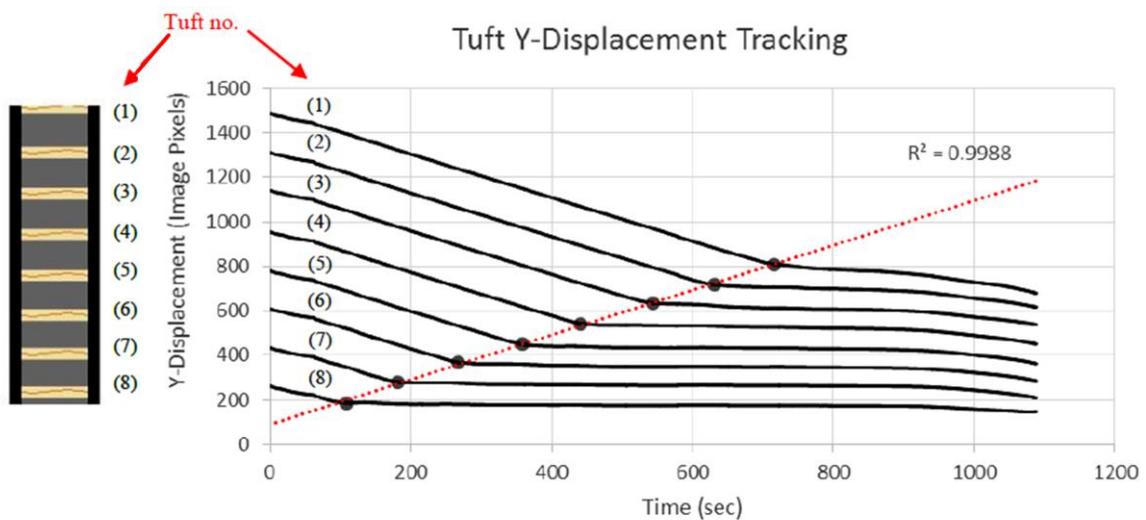
Figure 7. Pixel tracking of tuft movement in crush direction.

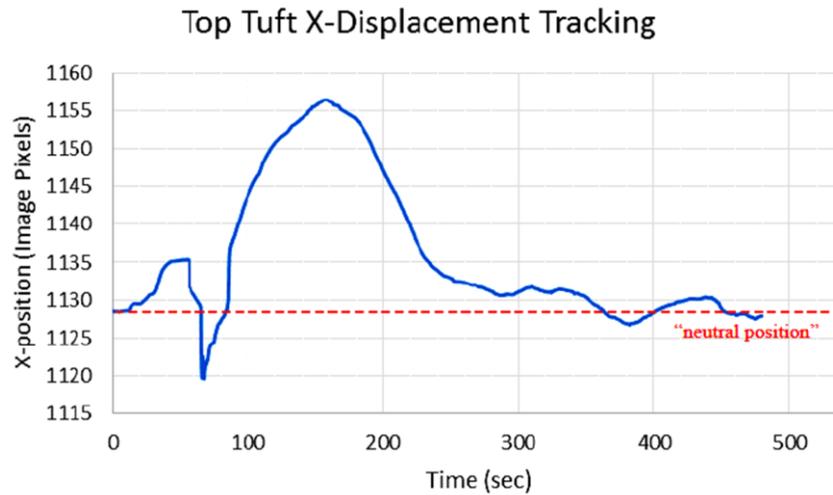
Figure 8. Perpendicular motion and recovery of tufts.

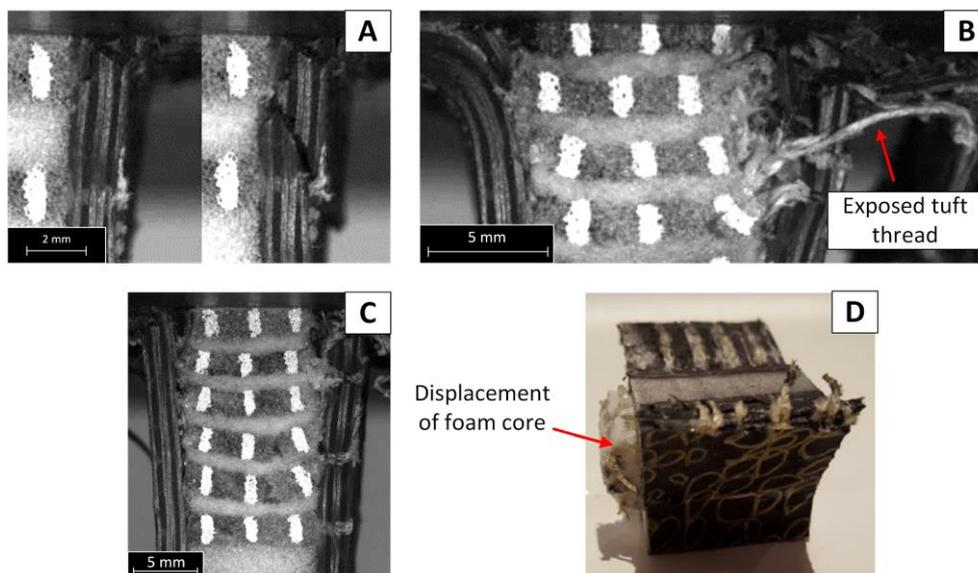
Figure 9. Observed failure mechanisms, **A** Skin fracture, **B** Thread pull-out, **C** Column Bending, **D** Core displacement.

The most common local failure mechanism observed was fracturing of the skins. Initially this took the form of delamination in the outer-most plies, occurring at the top surface of the coupon, where it was in contact with the crush plate. However predominantly skin fracture was observed around tuft sites, as

shown in Figure 9a, due to the resin rich area formed by the displacement of the fibres around the tuft.

Despite the mostly Mode I opening type failure mode of the coupons, typically failure of the tufts occurred due to shearing at the skin-core interface, however in one isolated case a tufting thread was observed to have pulled out of the resin column (Figure 9b). This is an interesting result as despite tufts providing a reinforcement through-thickness, it is rare for them to fail in tension as a result of the opening of the skins. The reason for this type of failure was not clear, however it could potentially be related to the alignment of the thread within the column when it is loaded, or perhaps a defect in the column that could cause it to fracture around the thread. It was also observed that the location of the tufts relative to the crush site did have some effect on their behaviour. If tufts were positioned close to the upper compression plate, an earlier onset of skin fracture occurred which led to a reduction in the overall compressive strength of the coupon. Also as crushing progressed, the foam closest to the crush front tended to act as a wedge, forcing down onto the tuft columns. Because the columns are fixed at each end, this downward force causes the columns to bend as shown in Figure 9c. In some cases this bending effect caused the columns to crack.

Generally, failure of the core was limited to in-plane crushing as the individual cells of the foam collapsed. In several cases, when the density of the foam reached a point that it could not be compressed further, fracturing took place and large pieces were forced out of the structure as shown in Figure 9d.
