Ultrasonic Detection and Sizing of Compressed Cracks in Glass- and Carbon-Fibre Reinforced Plastic Composites

M. E. Ibrahim^{1,2*}, R. A. Smith³, and C. H. Wang⁴

Abstract

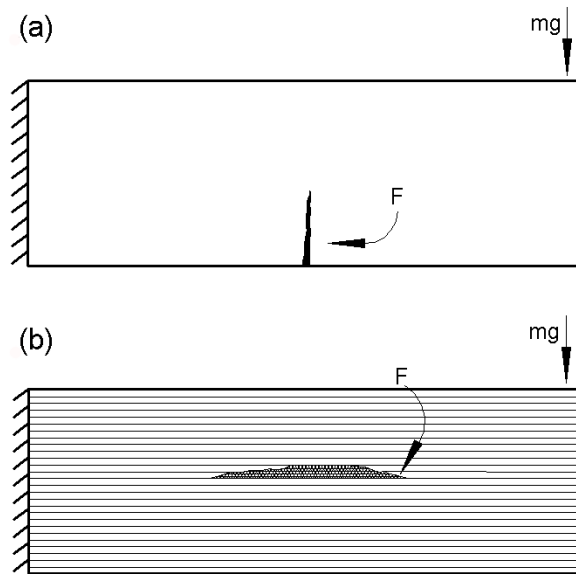
Figure 1. Schematic diagram depicting the crack closure problem in (a) a metallic beam, and (b) a composite laminate. Here, the loading due to gravity (mg) or other forces causes a compressive force F to act on the crack, resulting in closure.

Fatigue-induced cracking in metallic beam or plate structures typically occurs in the orthogonal plane to the applied stress along the surface of the structure (Figure 1a), whereas in FRP laminates, macro-scale cracking is generally manifested as an interlaminar separation between successive plies in the lateral plane (Figure 1b). Added to this different crack geometry, the highly orthotropic properties of the plies complicates the propagation of ultrasound in the laminates.

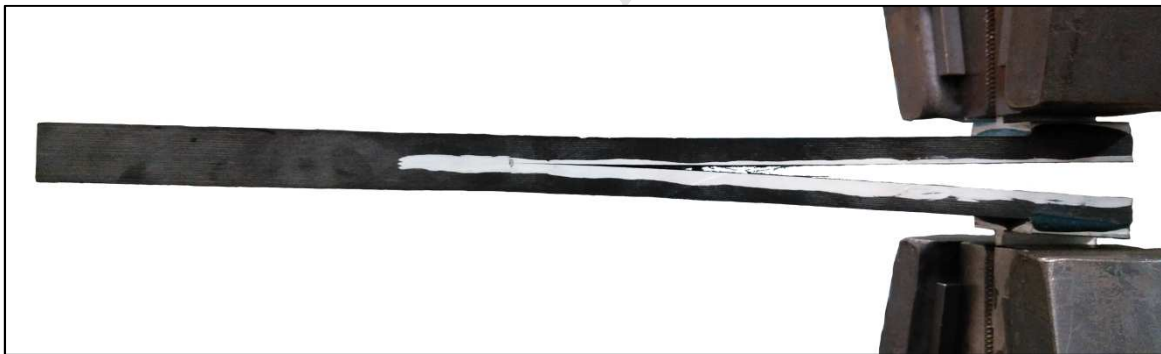
Figure 2. Carbon/epoxy laminate specimen undergoing static crack growth via DCB testing. The dimensions of the specimen are approximately $220 \times 25 \times 10$ mm.

The composite laminates were cut into suitable test specimens using a diamond-tipped saw and prepared for crack growth under static loading. The specimens were oriented such that the fibre direction was aligned along the length of the specimen so that the crack would grow along the fibre direction. Five carbon/epoxy (C1 – C5) and six glass/epoxy specimens (G1 – G6) were manufactured and used in the experiments. The initial crack was further grown into the specimens via a double cantilever beam (DCB) test configuration to a length of approximately either 110 mm, or 115 mm, resulting in a crosshead-to-crack tip length of approximately 98 ± 1 mm or 103 ± 1 mm respectively. Testing was performed in accordance with the ASTM test standard for Mode I interlaminar fracture toughness [17]. Figure 2 shows a carbon-fibre specimen undergoing crack growth measurements in the test machine. Despite the varying material properties of the carbon/epoxy and glass/epoxy specimens, the load required to propagate the initial crack along the beam was similar, being 240 ± 10 N.

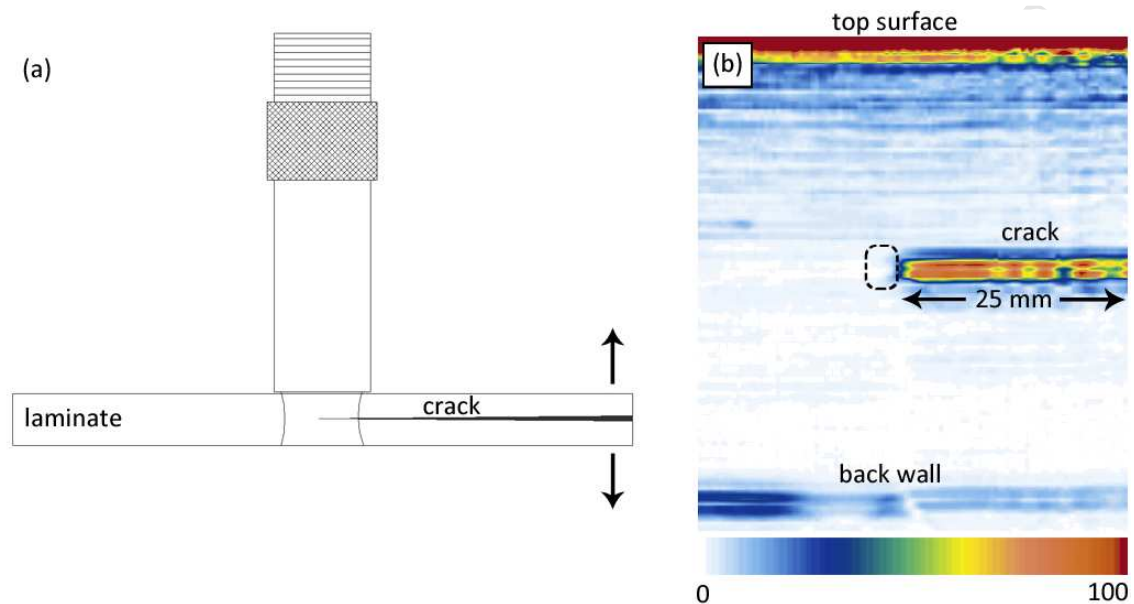
Figure 3. (a) Schematic diagram of the inspection performed at the crack tip, and (b) Typical cross-section ("B-scan") of the ultrasonic echoes detected from the specimen, relative strength shown on the graded colour palette. Notice the reduction in back wall echo strength over the crack region. The dashed box shows an approximate region of interest for this study, beyond the clearly identifiable reflection.

An ultrasonic inspection was performed on each specimen using a 5 MHz transducer (details given in Section 0) to characterise the tip region of the initial crack. Figure 3 shows a schematic diagram of the inspection setup and a detailed cross-section ('B-scan') of the ultrasonic echoes around the crack

tip, received from within a typical carbon/epoxy specimen. The specimen was not under any load during this initial inspection. The length of the crack shown in the image is approximately 25 mm, and the region of interest for the closed crack inspection is bounded by the dashed line at the tip of the visible part of the crack.

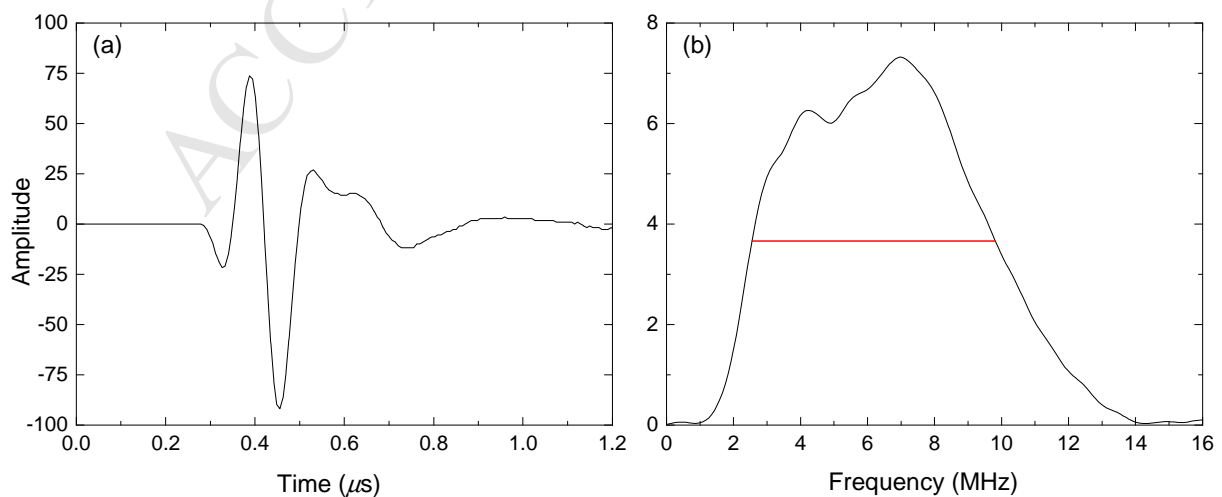
Figure 4. (a) Typical ultrasonic signal emitted by the piezoelectric transducers used in the study, as measured in water. (b) Frequency spectrum of the transducer signal, (red line – FWHM bandwidth).

The typical ultrasonic pulse incident on the laminate specimens (measured in water) is given in Figure 4a. The transducer is designed to produce a broadband response in order to limit the amount of ring-down at each interface, thus increasing the lateral resolution (ability to discriminate between closely spaced through-thickness layers). The signal shown was produced and measured by a broadband 5 MHz unfocused contact transducer, chosen to minimise 'ring-down' of the signal. Figure 4b shows the frequency spectrum of the signal, indicating a bandwidth of approximately 7 MHz, and a centre-frequency of 6.2 MHz.

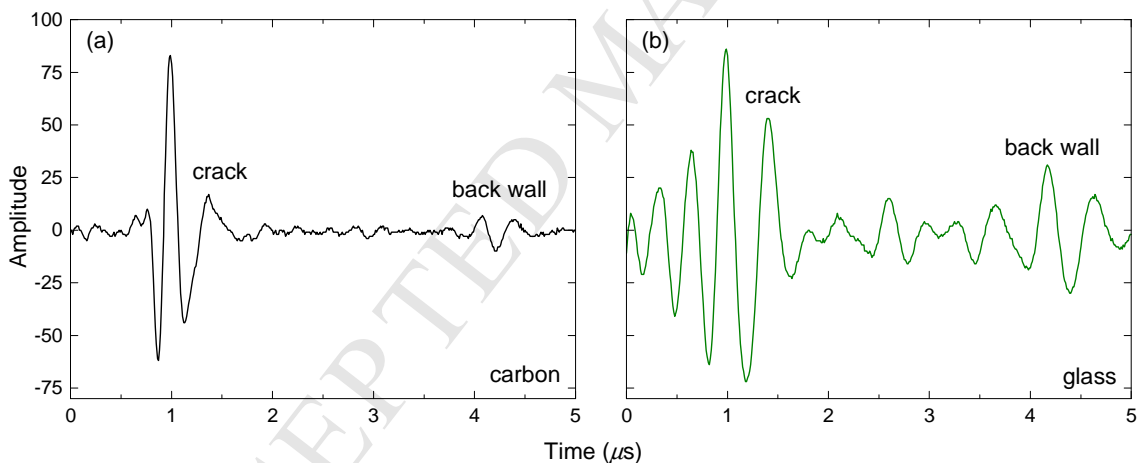
Figure 5. Typical signals obtained from pulse-echo inspection over the crack tip in the unidirectional (a) carbon/epoxy specimen C2 and (b) glass/epoxy specimen G4. Specimens were not under load.

Typical ultrasonic reflections obtained at the crack tip for a single-element pulse-echo inspection are shown in Figure 5, for the typical carbon and glass laminates tested. The large echo at the composite-crack interface is due to the correspondingly large acoustic impedance mismatch between the composite material and air. A distinct difference in the response from the crack tip region, and the frequency content for the glass/epoxy and carbon/epoxy laminates is obvious, with much more significant internal response occurring throughout the thickness of the glass/epoxy specimen.

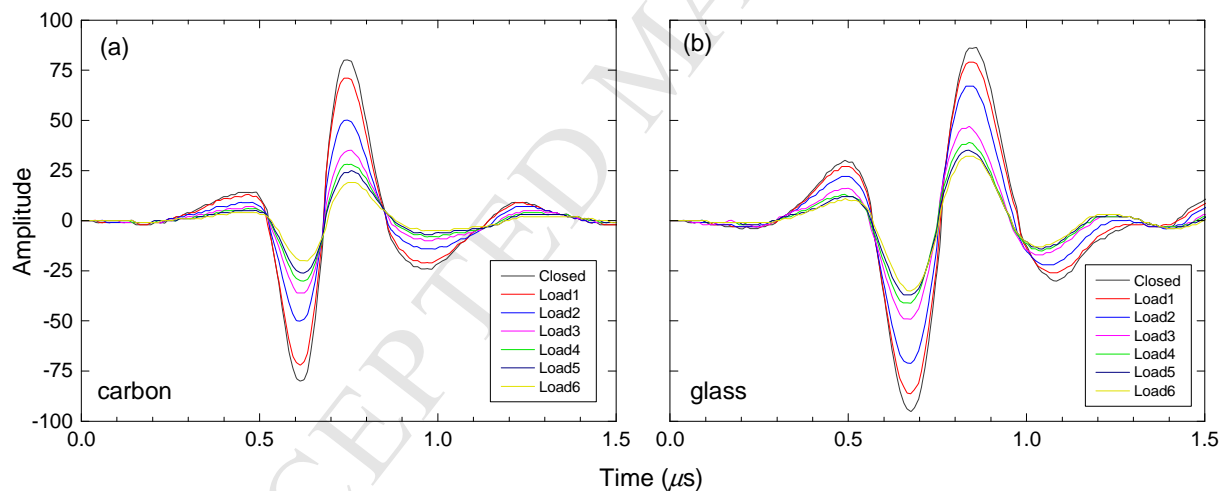
Figure 6. Typical ultrasonic transmission measured during opening of the laboratory-grown interlaminar crack in (a) carbon/epoxy specimen C2 and (b) glass/epoxy specimen G4. The amplitude scales for the two types of composite have been arbitrarily chosen for convenience of comparison.

Results showing the effect of crack opening/closure on the ultrasonic transmission through carbon and glass composites using the experimental method presented in 0 are shown in Figure 6, for a number of incremental 0.5 mm crosshead openings. The signal has been truncated to show only the waveform corresponding to the reflection from the region close to the crack tip. The consecutive increments of crack opening were linear, and designed such that the test machine crosshead-to-crack tip displacement would be the same for each test specimen. The amplitude scale for the Figure was set arbitrarily, given the significant increase in ultrasonic energy required to penetrate glass/epoxy laminates compared to carbon/epoxy, and the relative difference in ensuing echo strengths.

Similar qualitative behaviour was measured for both material systems, in which the magnitude of the increments gradually decreased as the crack reached a maximum opening (limited by the load at which further crack growth would ensue). There is an immediate effect on the amplitude of the

transmitted signal due to the opening of the crack, whereby the amplitude of the signal is reduced over several increments of crosshead displacement/opening. At higher loads, the probe tilt between the two transducers may become significant enough to noticeably reduce the transmission coefficient and thus the transmitted signal. The amplitude profiles for the two types of composite are shown in Figure 7, where each laminate type is normalised to a value of 100% at zero load. The scatter in the results obtained during the measurements was plotted as the uncertainty limits surrounding the mean values for the carbon and glass laminates in Figure 7 (shaded zones). This indicates a clear and repeatable crack closure effect on the ultrasonic signal transmission over a crack tip for both the carbon/epoxy and glass/epoxy laminates, which decreases gradually with crack opening.

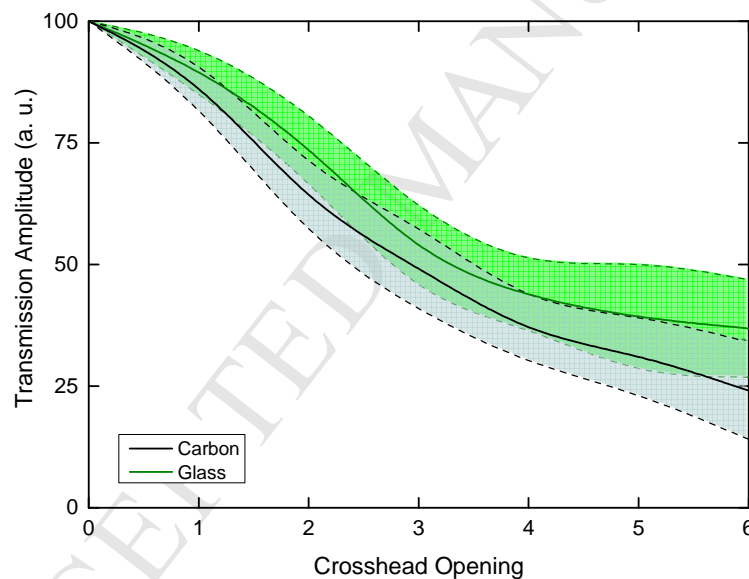
Figure 7. Reduction in ultrasonic transmission through the complete series of unidirectional carbon/epoxy and glass/epoxy laminate specimens. Average values are plotted in each case, with the extrema plotted in the shaded zones.

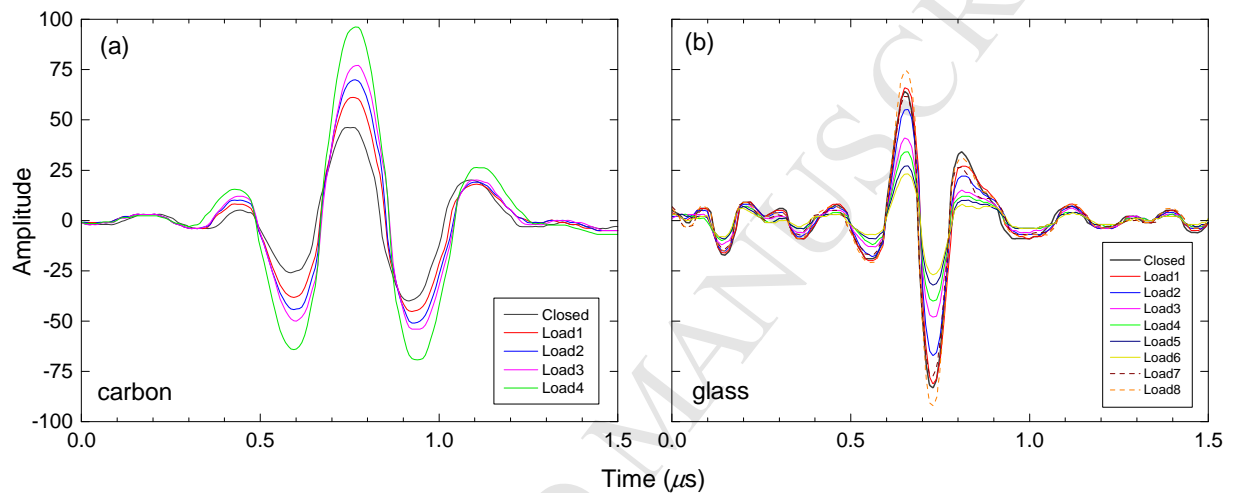
Figure 8. Typical ultrasonic pulse-echo reflection from the crack tip of the laboratory-grown interlaminar crack in (a) carbon/epoxy specimen C2 and (b) glass/epoxy specimen G4. Higher crosshead openings in the glass laminate are shown with dashed lines.

After performing pulse-echo measurements on the same set of specimens, a curious result was immediately obvious (Figure 8). In the carbon/epoxy laminates, the magnitude of the reflected wave

increases immediately upon opening the crack. However, in the case of glass/epoxy laminates, the magnitude of the reflected wave unexpectedly decreased initially, until the crack opening reached approximately 60% of the peak value, and then increased as shown in Figure 9. This effect was observed over a range of test frequencies on all the glass/epoxy laminate specimens. To our knowledge, such behaviour has not previously been reported.

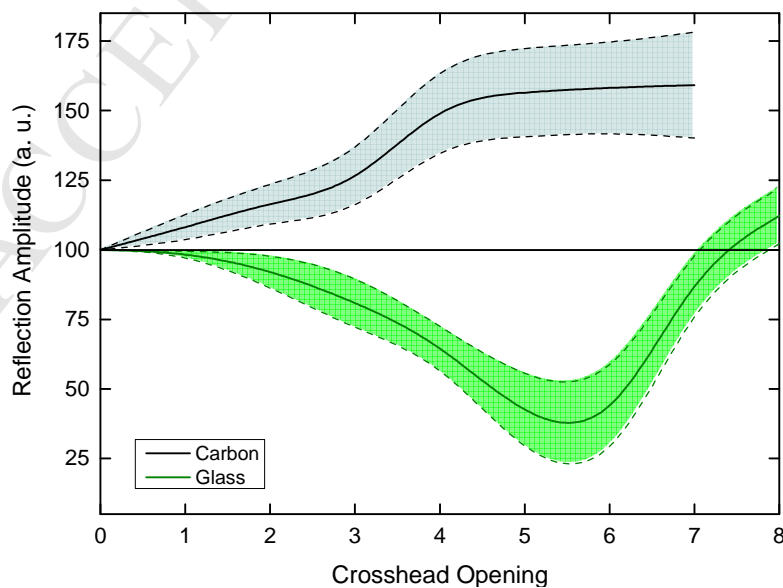
Figure 9. Relative ultrasonic pulse-echo response from the crack tip during crack closure/opening for the complete series of carbon/epoxy and glass/epoxy composites. The expected closure effect occurs for the carbon composite, whereas an opposite effect of a reduction in reflected ultrasound occurs initially in the glass composite, prior to being overtaken by the air-backed layer.

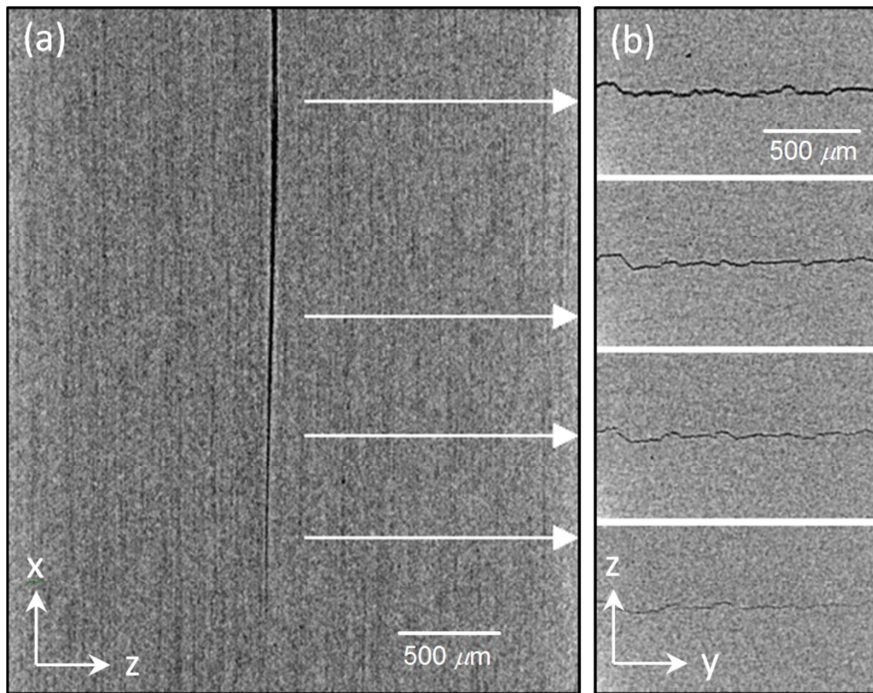
Figure 10. Nano-CT images of the crack in a carbon/epoxy laminate, viewed (a) along the length of the crack approaching the tip, and (b) Corresponding orthogonal images of the crack tip for the four slices shown along the crack. The crack length in (a) is approximately 3 mm, and the crack fronts in (b) are approximately 1.5 mm in length.

Figure 10 shows an image of a crack in a carbon/epoxy composite laminate, without any load applied, and a series of crack front images at various slices approaching the crack tip. The length of the crack shown spans approximately 3 mm, the part of the crack that was covered by the transducer face in the measurements made in this study.

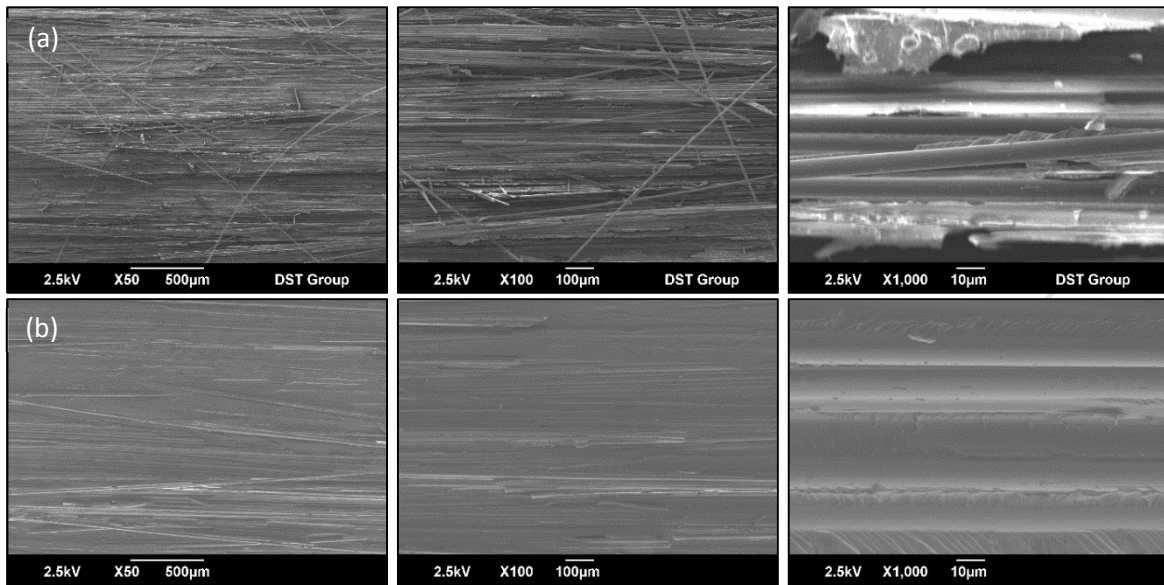
Figure 11. Electron micrographs acquired along the crack face in the (a) carbon/epoxy and (b) glass/epoxy laminates. Magnification from left to right: x50, x100, x1000.

The SEM examination was performed using a JEOL JSM-6490 instrument with an open crack surface that was prepared by forcibly opening the specimen after the load testing was complete. Images of the crack surfaces of the different composite laminates at an identical series of magnifications are given in Figure 11. It is clear from the micrographs that a considerable difference exists in the degree of disturbance of the fibres at the fracture surfaces, with the carbon fibres experiencing significant fibre breakage and pull-out, and the glass/epoxy surface showing substantially lower surface roughness.

A further mechanism that has relevance only at the crack tip may be the loss of sound energy due to a destructive interference via averaging over the full diameter of the piezoelectric transducer crystal, which was placed halfway over the visible part of the crack tip. The pulse-echo reflection from a resin-layer interface is out of phase with the reflection from a delamination or back-surface echo by $\pi/2$ [24], and the resin-layer reflection is significantly stronger in the glass/epoxy composite. Hence, there is a possibility that the response of the gradually-opening crack beneath the outer half of the beam interferes with the expected response from the open part of the crack. In the case of a phase difference of π between a slightly open crack and a very open crack, such interference would be a plausible explanation for the reduction in amplitude. This might be possible via the presence of an evanescent wave occurring in the air gap at the crack tip. At a sound speed in air 1/10 of that in the composite, a much smaller path length ($\sim 30 \mu\text{m}$) is needed in order to contain one half wavelength. The increased smoothness of the glass/epoxy laminate fracture surface (Figure 11) may also contribute to this effect.

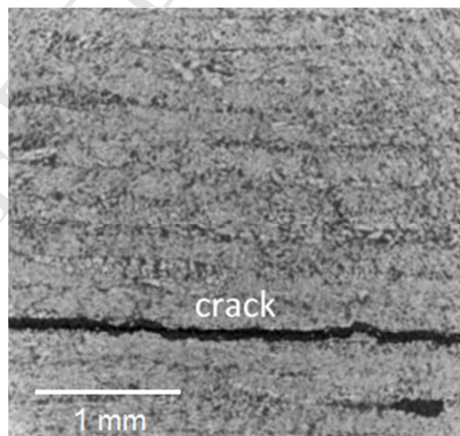
Figure 12. Nano-CT image of resin ply interface layers (horizontal) in a glass/epoxy laminate. Fibres run perpendicular to the page. Approximately 3.2 mm of the crack is shown. However, due to the unidirectional 0° layup, the distinction between successive plies is not always obvious.

Figure 12 shows a nano-CT image of the fibre-resin interfaces through the plies in a glass/epoxy laminate. For the specimens investigated in this study, the plies were laid up unidirectionally at 0° , and hence there is some movement of the fibres between successive plies.

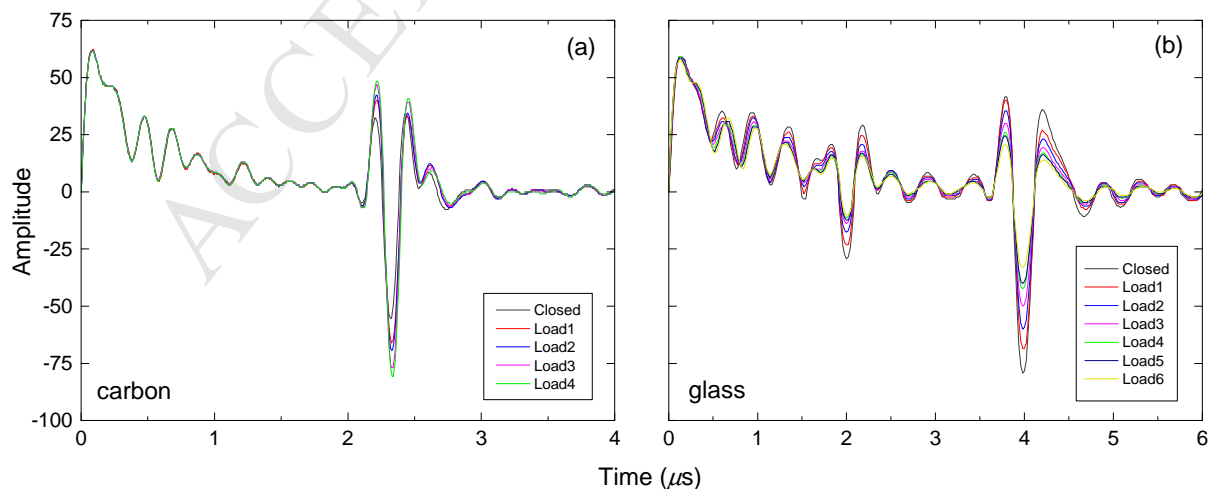
Figure 13. (a) Complete reflection waveform for carbon/epoxy specimen C4. (b) Complete reflection waveform for glass/epoxy specimen G6. The much larger variation in the early part of the waveform (prior to the crack reflection) on loading is obvious.

A close examination of the full waveform travelling through the composite specimens, in particular the uncracked laminate or the sub-laminate above the crack plane, reveals a noticeable change in the internal reflectivity of the glass plies prior to the crack echo. Figure 13 shows a series of reflection waveforms for a series of crack-opening displacements to a depth (time) pertaining to the back face of the laminate. For carbon/epoxy laminates, the waveforms before the crack reflection are closely superimposed, whereas the glass/epoxy waveform shows distinct differences from the point of entry into the composite through to the crack reflection. Here, the amplitudes of the internal reflections as well as the crack reflections decreased as the opening displacement increased.

In order for further analysis to be made on the waveform, the pre-crack signal was corrected by removing the low-frequency transducer excitation, via a simple quadratic correction to the signal amplitude. The combined effect of the material prior to the crack on the ultrasound beam was then measured by integrating the area under the curve for the full-wave-rectified signal, under the various loading conditions.

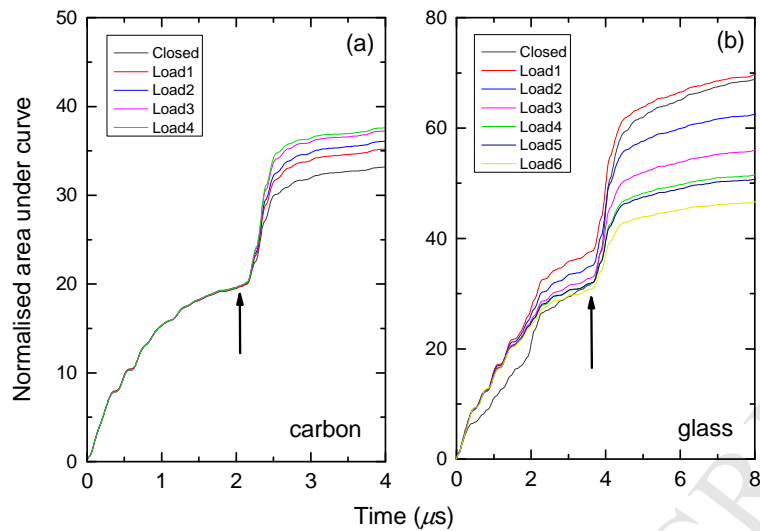
Figure 14. Cumulative area beneath the rectified (a) C4 carbon/epoxy and (b) G6 glass/epoxy ultrasonic signals for the thickness through which ultrasound is transmitted. The arrows indicate the point in time at which the crack signal appears. A clear variation between the glass/epoxy signals occurs prior to the crack plane, whereas the carbon/epoxy signals are identical in this regime.

The cumulative areas under the reflection waveform curves for each of the loading states are shown in Figure 14. For the glass/epoxy composite, the behaviour of the ultrasonic response mimics the unexpected behaviour measured at the crack tip itself, in that the 'closed' state results in stronger reflections than any of the open states. The behaviour continues consistently as the waves travel through the composite. In the case of the carbon/epoxy specimens, the curves preceding the crack plane are independent of the loading condition, and differences are only observed beyond the crack tip depth. Hence, it can be deduced that this material effect is present throughout the loaded glass/epoxy laminate, rather than a directly-resultant effect caused by the measurement at the crack tip, and should be expected in glass-fibre laminates of similar construction. The material effect appears significant enough to negate the expected influence of the opening of the crack tip, as occurs for the carbon/epoxy composites. As the material effect occurs evenly in the through-thickness direction, its 'strength', relative to that of the expected increase from an open crack will be thickness-dependent. This issue will be particularly exacerbated in thick composite laminates, where a defect may be buried beneath several dozen, or even hundred, composite plies.

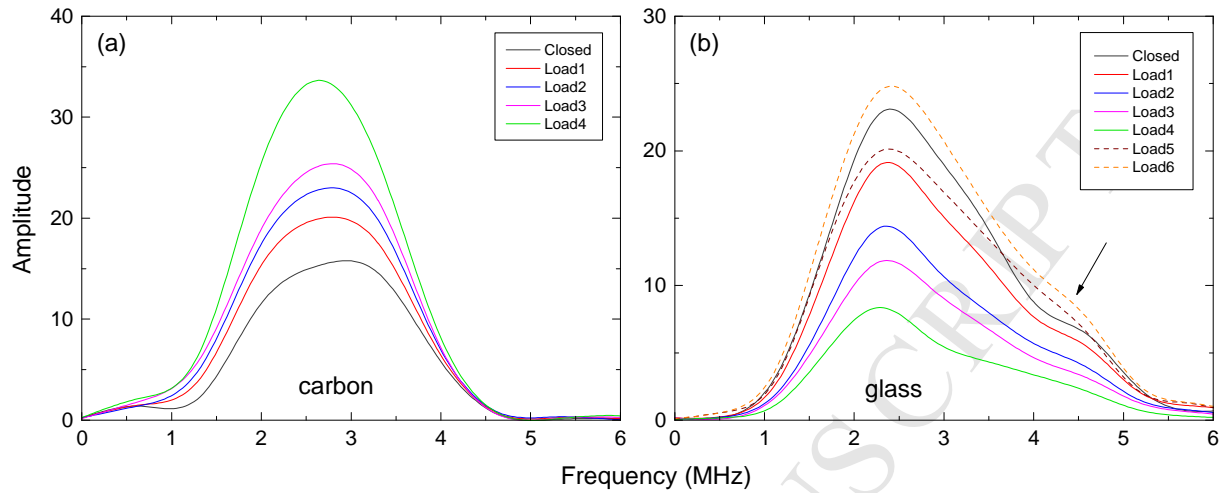
Figure 15. Frequency spectra obtained via FFT for the crack reflection from two crack-opening series of (a) carbon/epoxy specimen C4 and (b) glass/epoxy specimen G6. The arrow indicates a possible higher-order effect in the glass laminate. The reverse amplitude increase in glass/epoxy is also clear in this colour series.

The frequency spectra of the reflected ultrasonic waveforms were analysed in order to investigate the likelihood of the crack tip providing an energy storage mechanism in the early stages of crack opening. Figure 15 shows the frequency spectra obtained for a series of crack openings in typical carbon/epoxy and glass/epoxy laminates, and show a frequency response at the lower end of the input signal range (Figure 4b) in both cases. The peak response of the carbon-fibre laminate is at approximately 2.8 MHz, and at approximately 2.3 MHz in the glass-fibre laminate, both well below the centre frequency of the input signal. Of particular interest is the skew in the glass composite frequency response, possibly due to an unresolved higher harmonic peak that appears in the low load stages of the glass/epoxy specimens, until the signal reduction effect has been overcome by the significant opening of the crack tip, whereupon it weakens (see arrow indicating the location in Figure 15b). The difference in frequency spectra may provide some explanation for the apparent

difference in reflectance upon opening the crack in the glass laminate, and warrants further investigation.

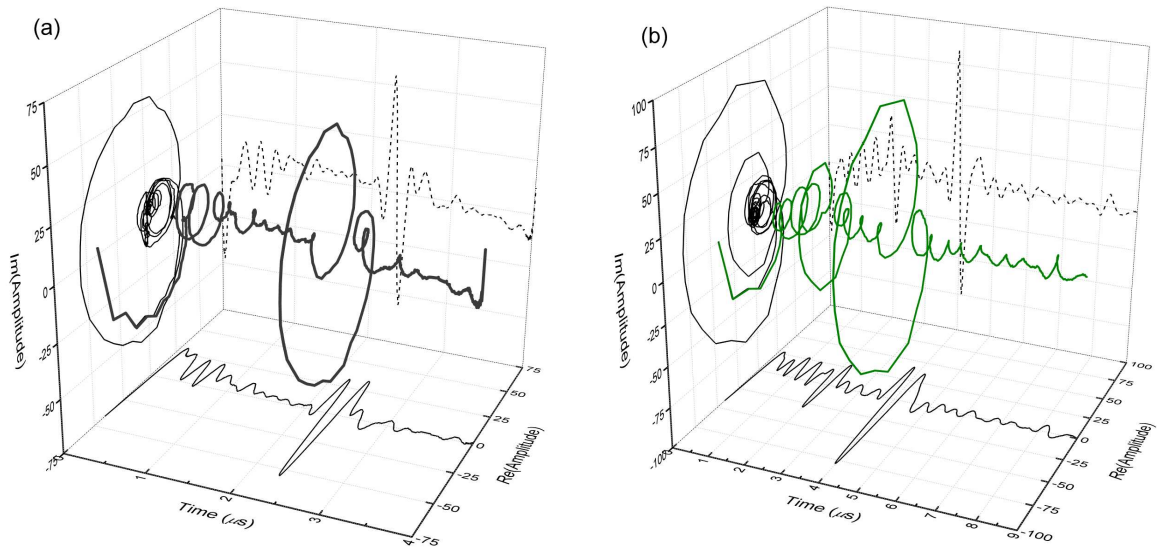
Figure 16. Real, imaginary and analytic signal for an ultrasonic pulse-echo response from (a) carbon/epoxy specimen C4 and (b) glass/epoxy specimen G6. The large response from the crack tip is at the centre of the waveforms.

The phase behaviour of the waveforms was studied by construction of the analytic signal via the application of the Hilbert transform to the real (acquired) waveform signal, following the approach of other authors [23,24]. The instantaneous amplitude is given by $Ae^{i\varphi} = Re(x) + i Im(x)$, where A is the instantaneous amplitude, φ is the instantaneous phase, and $Re(x)$ is the real, measured signal. The analytic signal of the echo response from the crack tip in a carbon/epoxy laminate is shown in Figure 16, and provides insight into the true energy contained within the waveform.

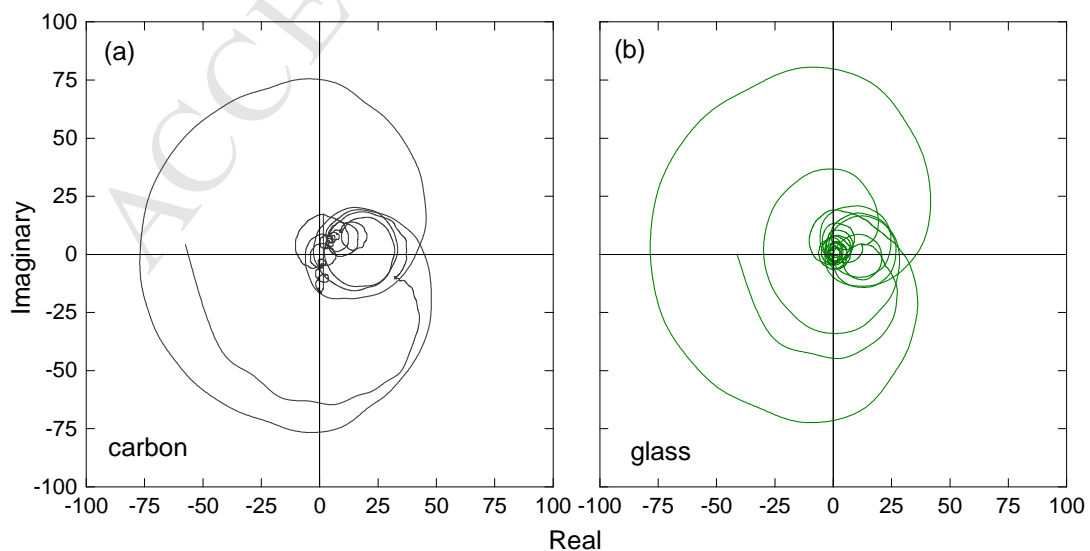
Figure 17. Normalised waveforms received from the (a) carbon/epoxy and (b) glass/epoxy composite laminates shown in Figure 16. The waveform timebase includes the period from introduction into the laminate through to the back wall, via a mid-plane crack, shown in a complex plane presentation.

Of particular interest is the real vs imaginary amplitude presentation, as shown in Figure 17. The minor loops about the origin are not easily discernible when viewing the ultrasound through the entire specimen in these realistic layouts due to variations in the spacing and thickness of both the ply and resin interface layers. The traces shown in the Figure are for the specimen with zero load.

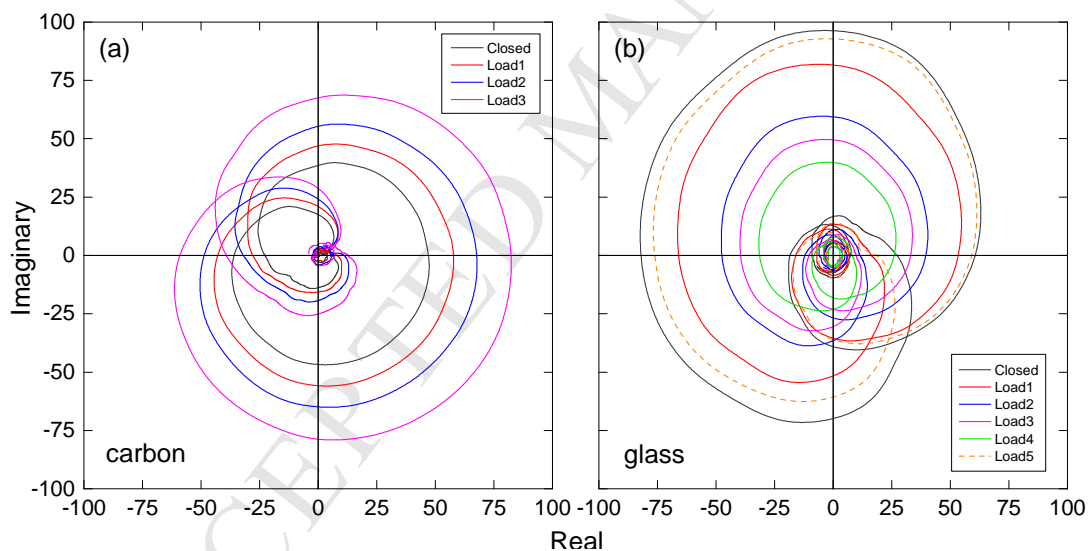
Figure 18. Normalised complex plane loops for the ultrasonic reflections for series of openings from the crack in (a) carbon/epoxy specimen C4 and (b) glass/epoxy specimen G3.

Figure 18 shows a number of phase loops for crack-opening measurements made on carbon/epoxy and glass/epoxy specimens. The loops shown here include the crack reflection signal only, and the reverse amplitude behaviour between the carbon and glass composites is again obvious. The dashed line in Figure 18b indicates the load case where the signal amplitude has passed through the minimum value and increased to approximately the same level as for the closed crack (no load) state.

Immediately obvious is the significant phase rotation occurring between the carbon and glass composites, as well as the greater degree of variability in the phase rotation of the various load conditions in the glass composite. The “Load5” state in the glass/epoxy laminate (Figure 18b) shows

the case where the signal has returned to a similar amplitude to that of the specimen at rest, with a very similar form in the complex plane. The phase response in the glass/epoxy specimens is what would be expected from a normal resin layer under compression, as is the amplitude response, up to the higher loads. The change in response suggests a loading mechanism that closes the crack during the initial phases, although the exact nature of this behaviour has not yet been determined.
